Woolooga Solar Farm, Lower Wonga, Queensland (EPBC 2019/8554)

Appendix D Other Offset Area Photos

Annual Compliance Report

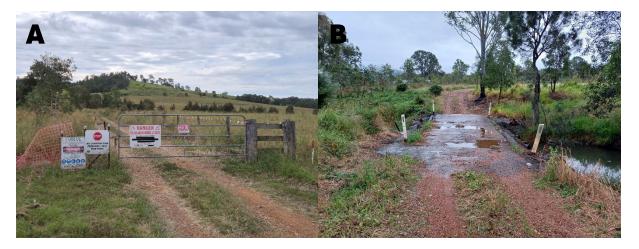
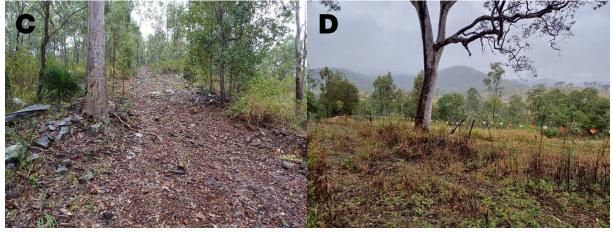
A-Main entrance gate, B-Waterway barrier crossing, C-Access track and D-Fence with visibility tags

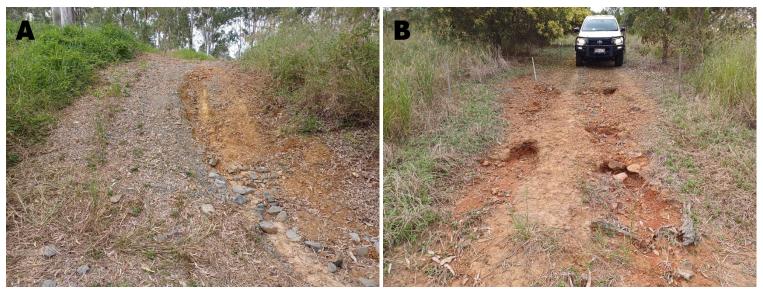
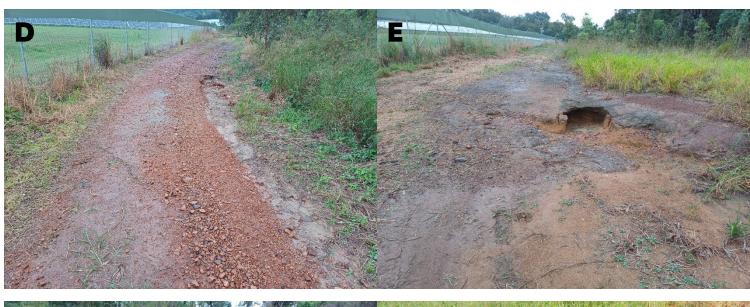
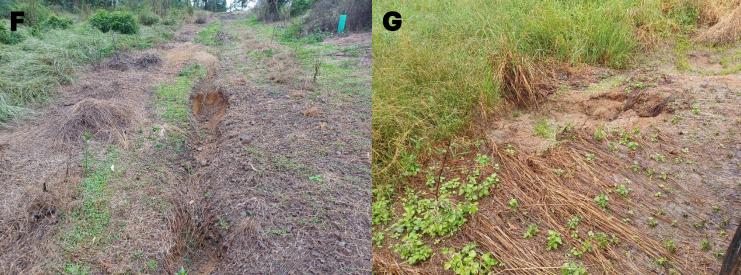
Erosion within offset access track

A-Erosion point 1, B-Erosion point 2, C-Erosion point 3, D-Erosion point 4, E-Erosion point 5, F-Erosion point 6 and G-Erosion point 7.
