ANNUAL COMPLIANCE REPORT

**WOOLOOGA SOLAR FARM, LOWER WONGA
(EPBC 2019/8 554)**

PREPARED FOR: LIGHTSOURCE BP

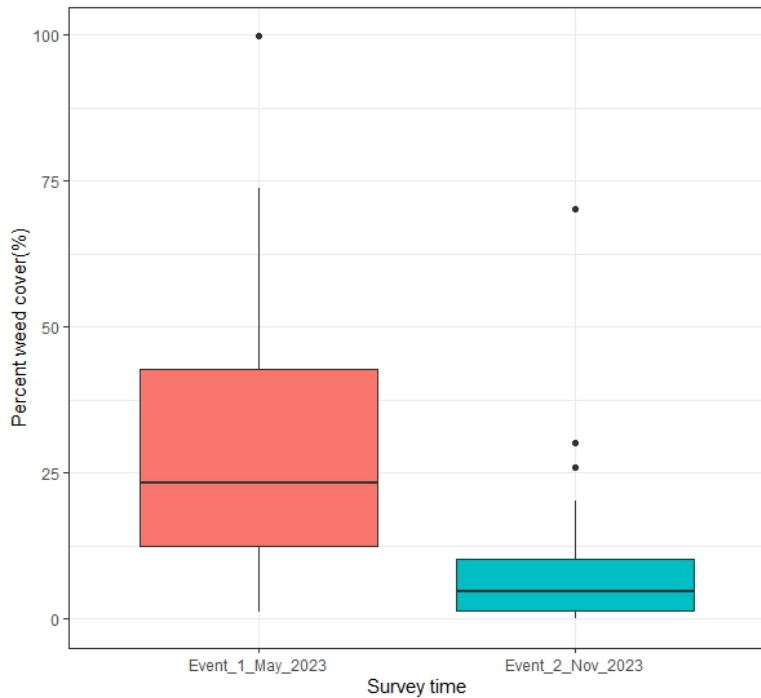
Figure 1 Range of weed coverage in sample plots

Eighteen (18) introduced species were recorded by the second monitoring survey (November 2023), with total weed coverage within individual monitoring plots varying between 0.2% to 70.1%. There was a gradual reduction in the number and percentage of cover of weeds from the survey 1 to survey 2. The box and whisker plots in **Figure 1** highlight the differences in the data distribution and medians between monitoring surveys.

In the first survey, three of the recorded weed species; *Lantana camara*, *Sporobolus sp.* and *Tecoma stans* are Category 3, falling within the OMPs definition of High Threat Weeds (HTW). In the second survey, two of the recorded weed species; *Lantana camara*, and *Sporobolus sp.* are Category 3, falling within the OMPs definition of High Threat Weeds (HTW) and they accounted for approximately 20% of the total weeds encountered.

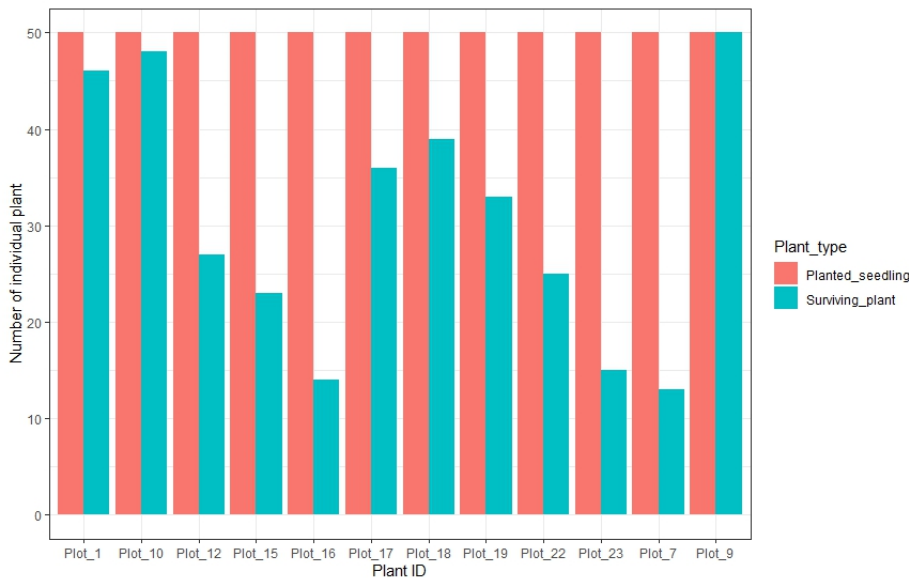
Figure 2 Survival monitoring survey compared to initial planting conditions

Twelve (12) planting survival plots were placed within Regeneration Zones across the offset site and 50 planted seedlings were monitored at each location (refer to **Plan 1**). During survey 2, seedlings planted in 8 out of the 12 had a survival rate of about 66.7% while in the remaining plots, the number of plants that survived was below 25 (33.3%). After 3 years seedlings planted in plot 9 all survived, whereas in plot 7 only 13 planted seedlings survived (refer to **Figure 2**).

Additionally, some observations within the monitoring plots include overgrowth of *Chloris gayana* in plot 18, and evidence of established natural regenerating plants in plot 16.

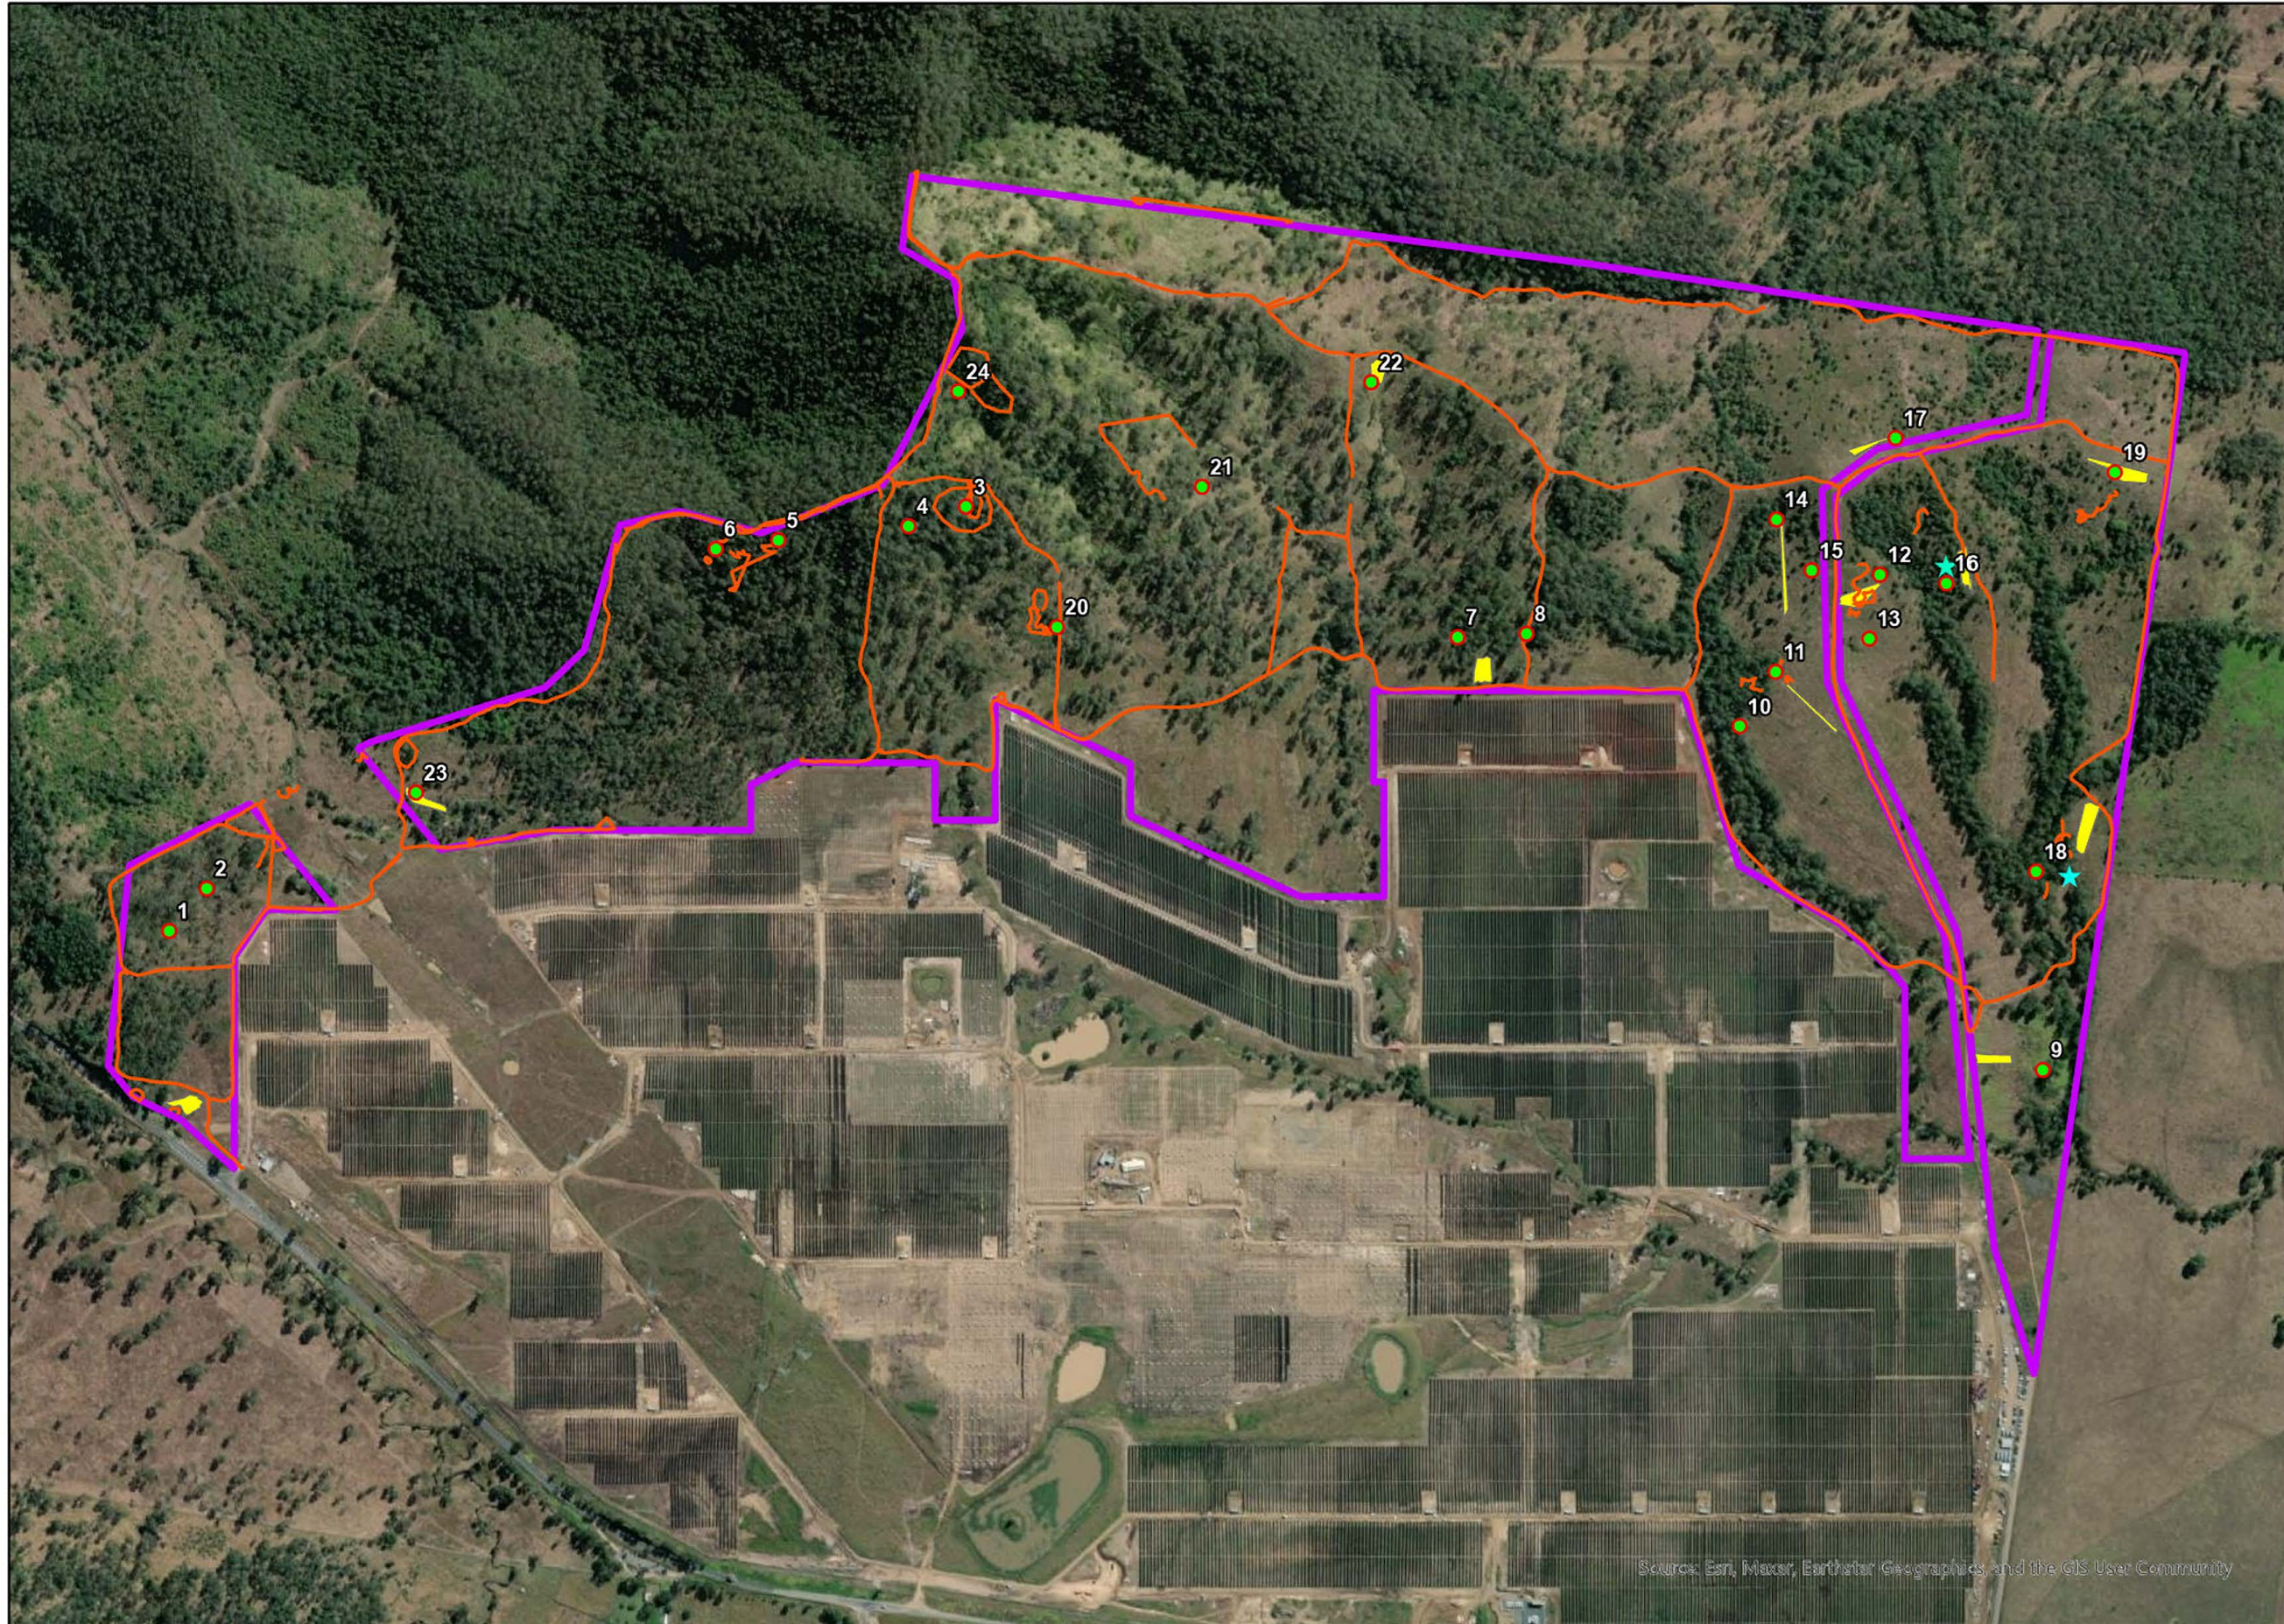
Plan 1. Offset Site Monitoring Locations

An additional survival planting assessment was undertaken on May 14th, 2024. It was noted that only two plots (16 and 22) evidenced poor average health of tube stock. Additionally, 5 plots showed counts over 43 alive plants whereas other 5 plots contained between 39 to 29 survivals; only two plots evidenced counts under 29 survivals (refer to **Plan 1**, and **Table 7**).

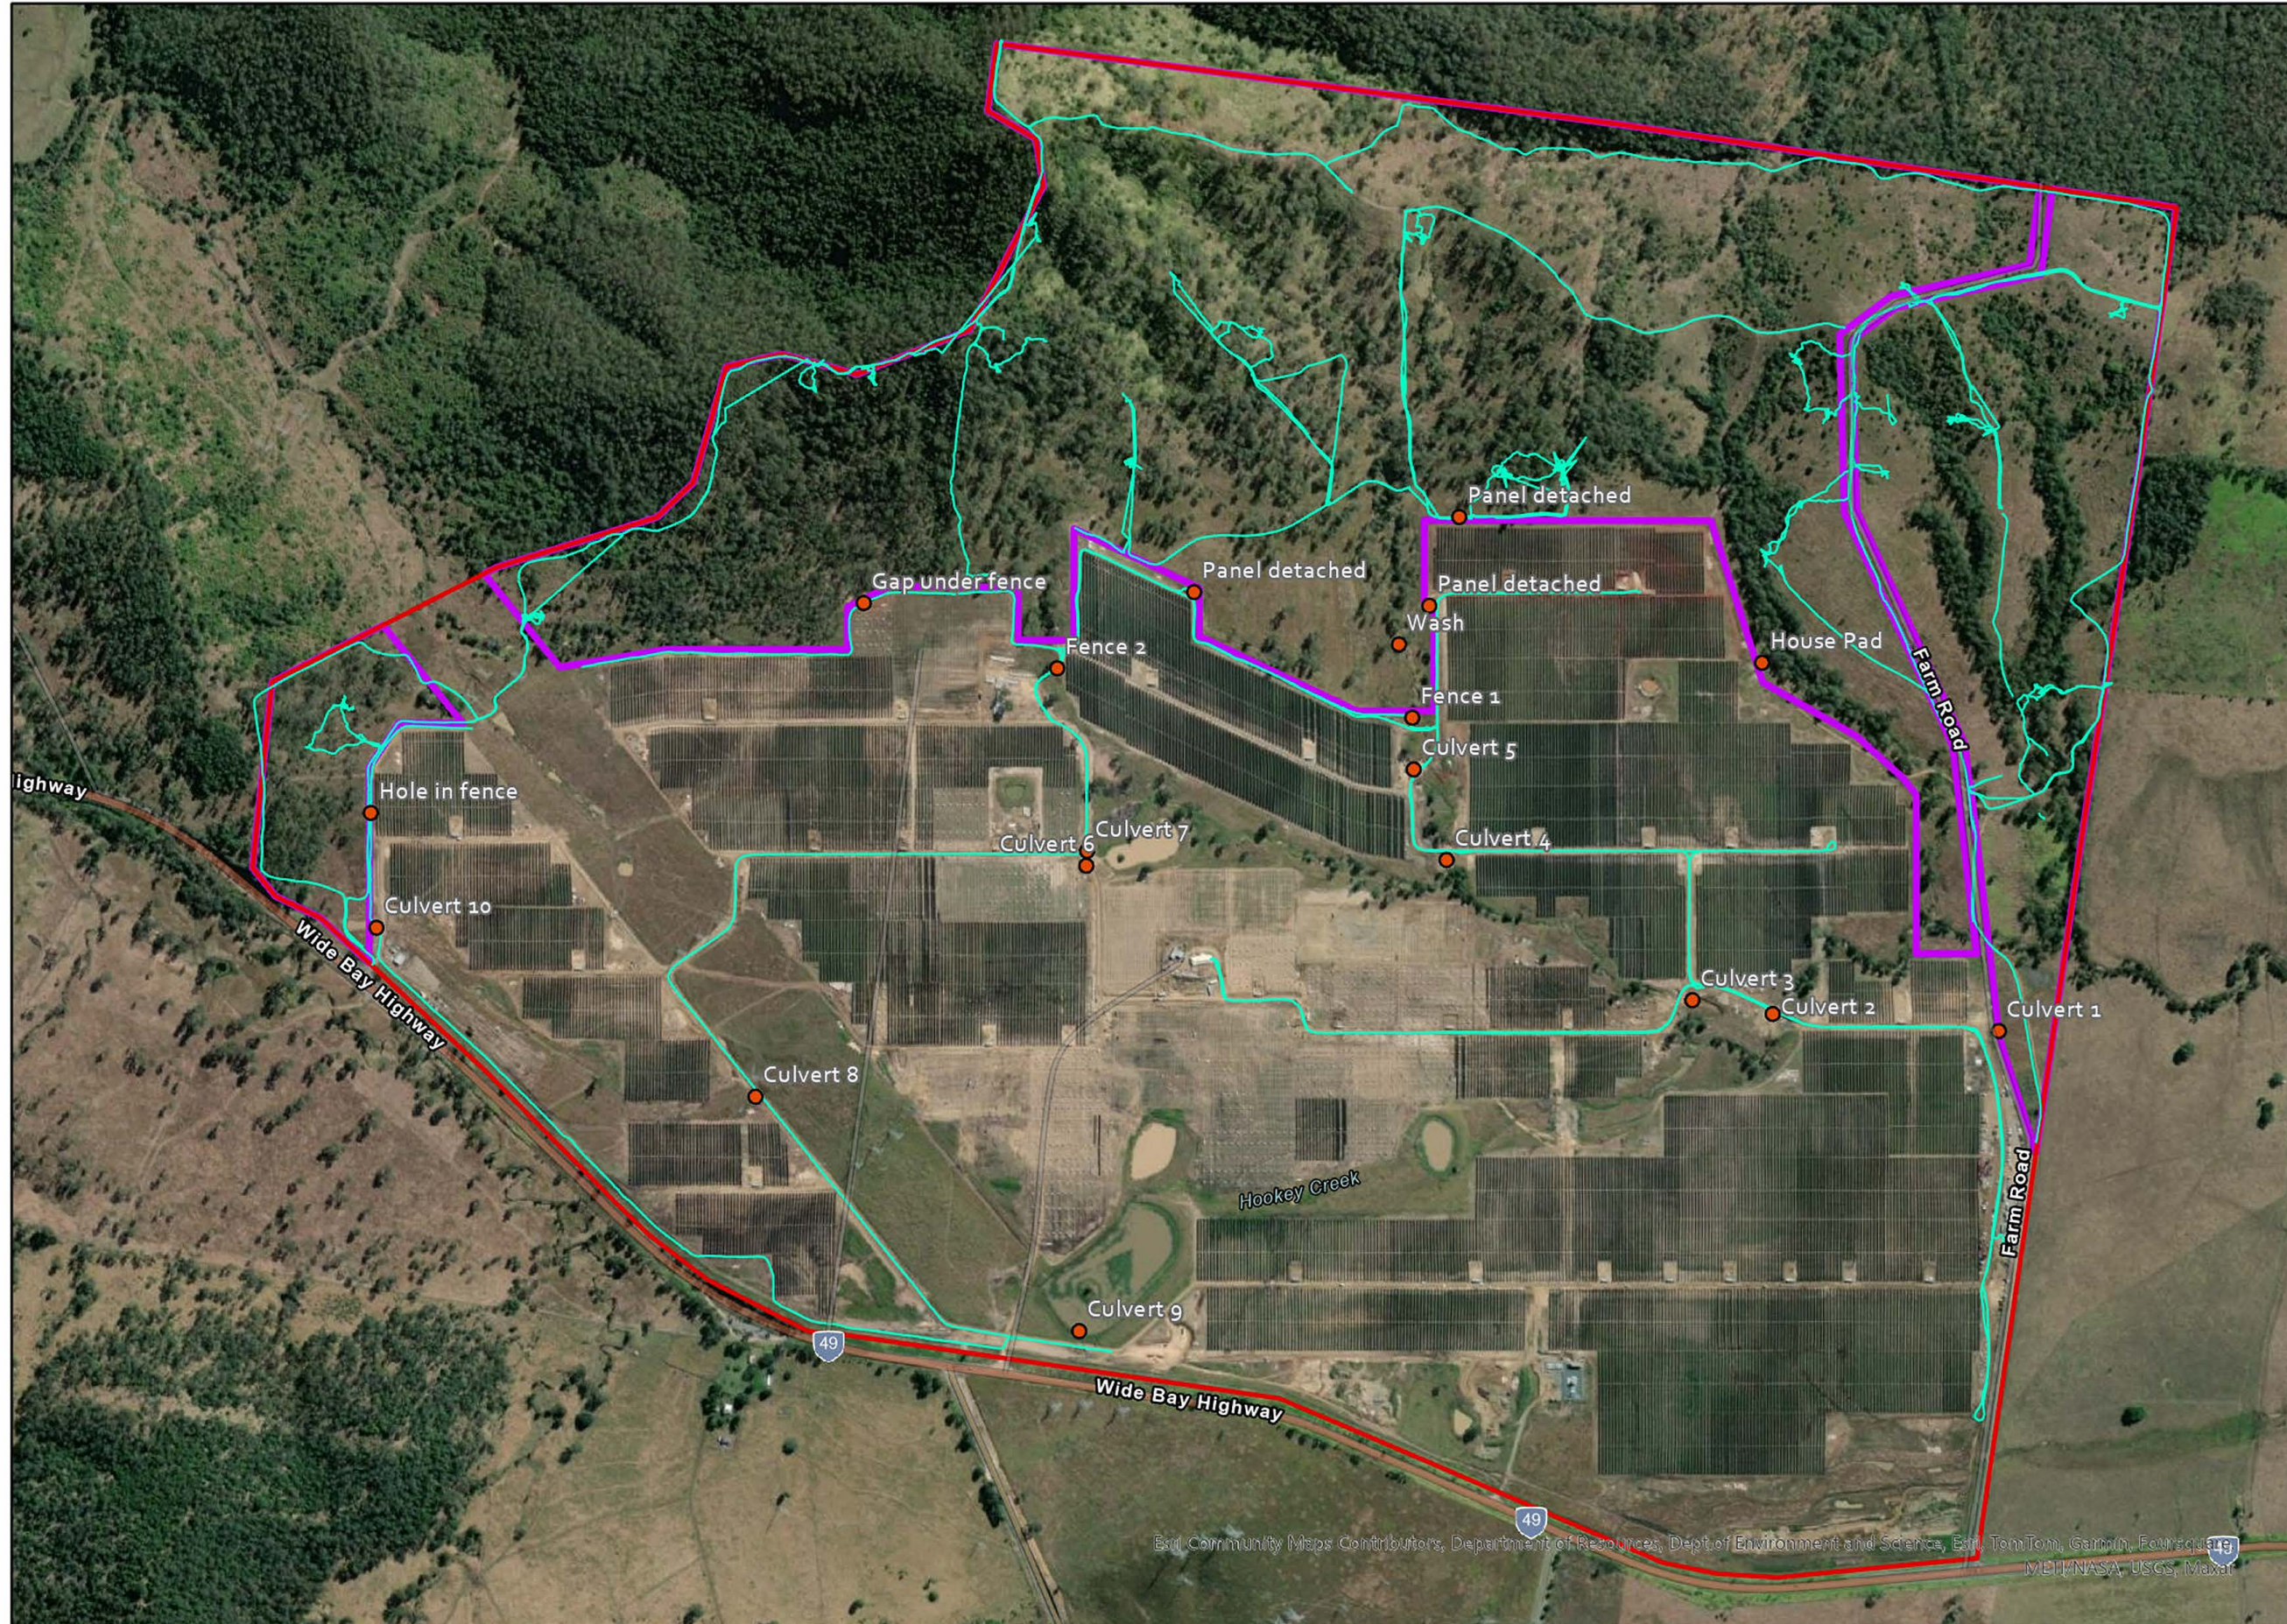
Plan 2. Site Audit - observation points

Table 9 below, describes the general outputs from the audit site including both impacted area (solar farm premise) and the offset area conditions (refer to **Plan 2**). It was found that there has been no additional clearing of habitat, and riparian corridor vegetation has been retained within the solar farm premises as per conditions of approval. Additionally, all the water crossings evidenced fish passage friendly designs and are currently functioning as per Fisheries legislation. Weed control is ongoing within both areas due to historical disturbances of the site resulting in high initial weed load (Refer to Plan 6 in ACR1 for further information about the location of weed infested areas).

Solar farm area	Additional clearing sign		No additional clearing beyond the approved development area was identified during the audit (Refer to Plan 2 , and Appendix C).
	Calming measures and speed limits signs of traffic management on site		No speed limits or traffic calming measures were identified on the road network within the solar farm. The only signs observed were the narrowing of the road width at the culvert crossings (Refer to Appendix C).
	Perimeter fencing status. Feral animals fencing		An overall good condition of the perimeter fencing was recorded during the audit. However, there are two minor gaps made by wildlife passage that will require repairs (Refer to Appendix C).
	Fencing particularly around the demolition areas mentioned in ACR2. Koala exclusion panels condition		The fencing around demolition area reported previously by ACR2 is currently in good condition. Out of the entire perimeter fence, only three koala exclusion panels were found loose, requiring follow-up repairs (Refer to Plan 2 , and Appendix C).

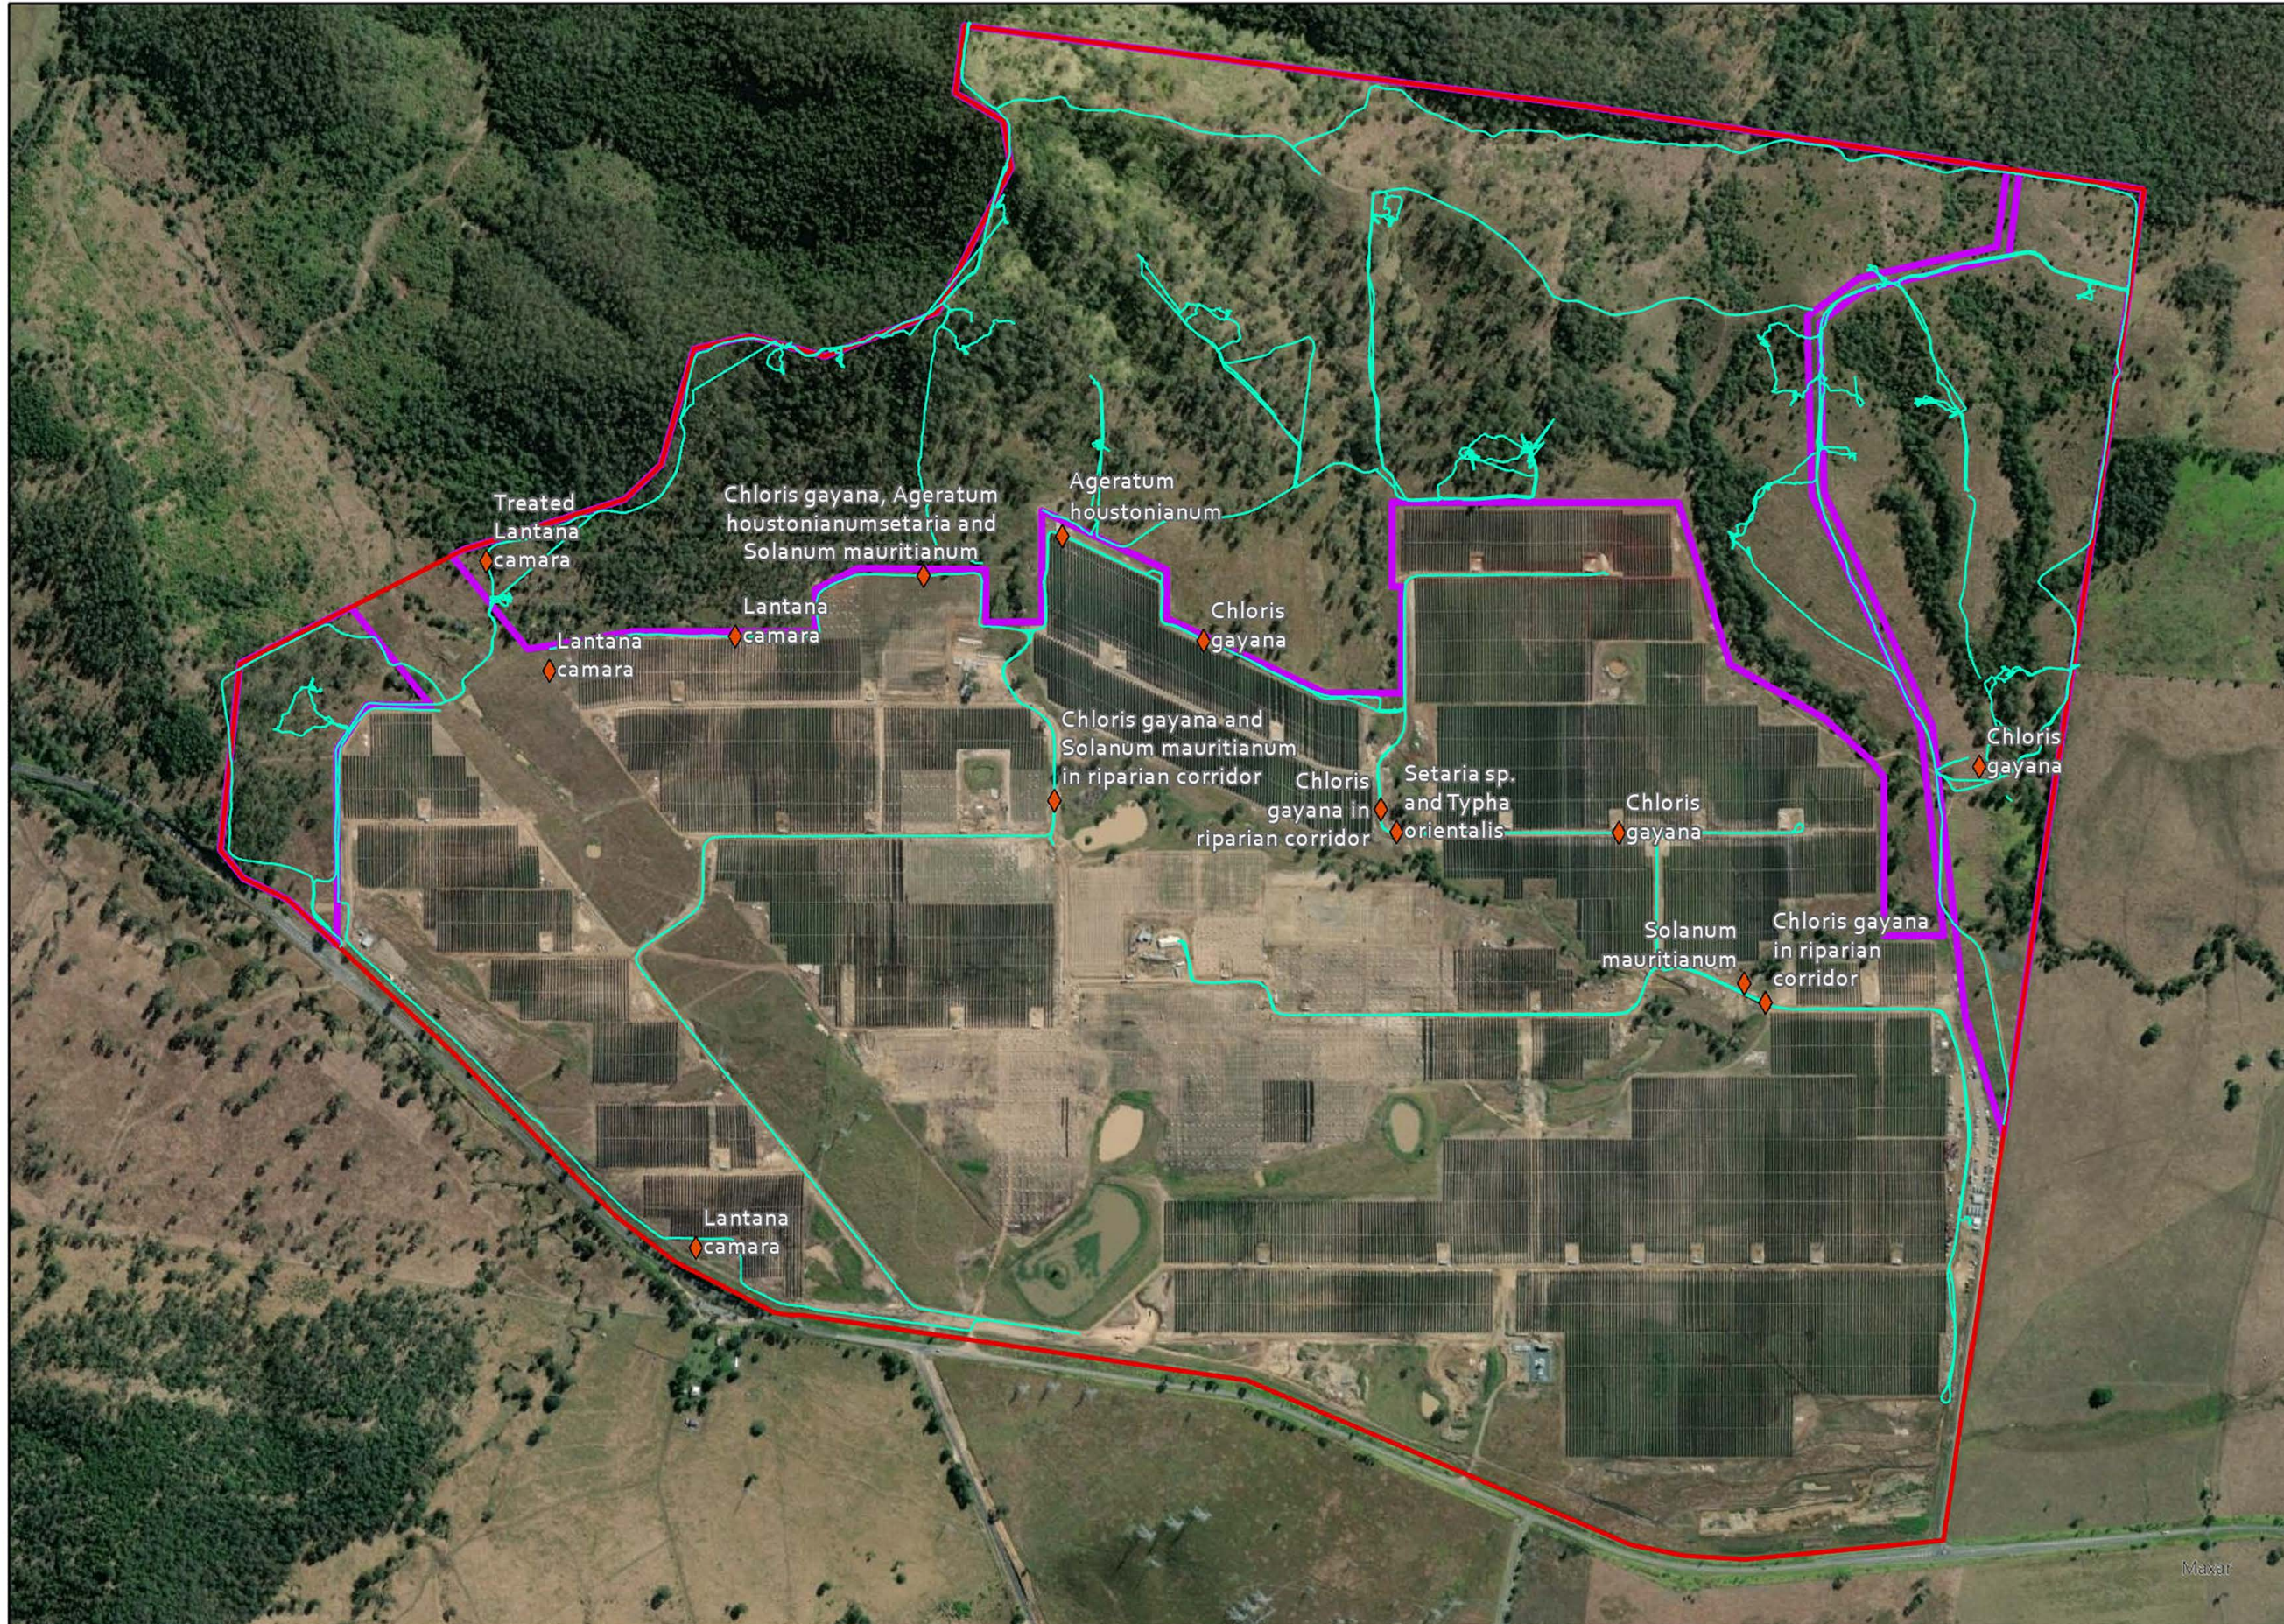
Plan 3. Site Audit - weed observations

Location	Feature	Condition	General Audit Observations
	Weeds infestation degree, species, management evidence		A large extent of weed presence along the riparian zone was identified during the audit, particularly a continuous strip of approximately 840 m ² between Culverts 4 and 5. The most predominant environmental weeds observed on site included Rhodes grass (<i>Chloris gayana</i>), and Tobacco bush (<i>Solanum mauritianum</i>). No evidence of weed management within the riparian zone was observed. The general maintenance, consisting of mowing, is limited to the area along the solar panels (Refer to Appendix C).
	Signs of stock within		Stock animals are not permitted within the solar farm, and there were no signs of livestock during the site audit (Refer to Appendix B).
	No go, or conservation area signalling evidence		No evidence of signalling related to the riparian zone was found during the audit. However, it is important to note that the construction of the solar farm is currently completed, and maintenance works are restricted to the solar panels. Therefore, despite the lack of signalling, the riparian corridor has been kept without interventions (Refer to Appendix C).

Location	Feature	Condition	General Audit Observations
Offset area	Fencing	Fencing condition, visibility tags	The northern boundary fencing is in good general condition, with no signs of damage to barbed wire fence wire or poles. Additionally, the visibility tags along the top wire showed a general good condition (Refer to Plan 2, Plan 4, and Appendix C).
	Planting areas	Photo of the planting areas, general evidence of the ongoing works	All designated planting areas show evidence of assisted planting and follow-up maintenance work, including weed control. Additionally, the most recently planted tube stock was observed with protective tree guards (Refer to Plan 2, and Appendices B and C), tree guards have been removed from more established plantings.
	Weed infestation	Photos of treated areas. Evidence of weed on site	The fire trails across the offset site evidenced good drivable conditions during the audit. The terrain is well maintained with no signs of washouts or erosion, and clear visibility due to effective weed management on the tracks. In terms of the rehabilitation zones, formerly Lantana infested areas on the central and eastern portions of the site have been successfully treated and remain Lantana free. Some previously treated areas on the north and southwest sides of the site show recurrent weed infestation. The predominant recurrent weed species on site are <i>Lantana camara</i> , Guinea grass (<i>Megathyrsus maximus</i>), and Rhodes grass (<i>Chloris gayana</i>) (Refer to Plan 2, Plan 3, and Appendices B and C).

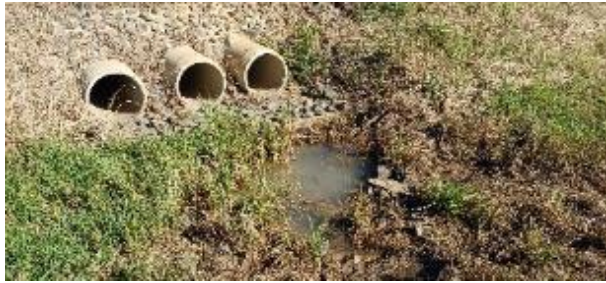
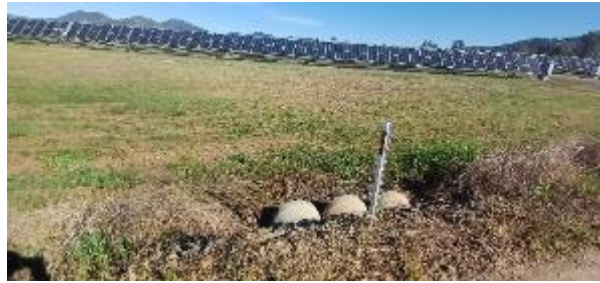
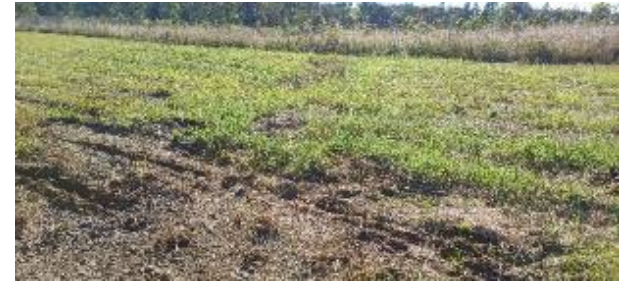
Plate 1 Culvert 1 WWBW conditions. Left to right showing culvert facing northeast; culvert facing southwest; and general condition of the waterway.

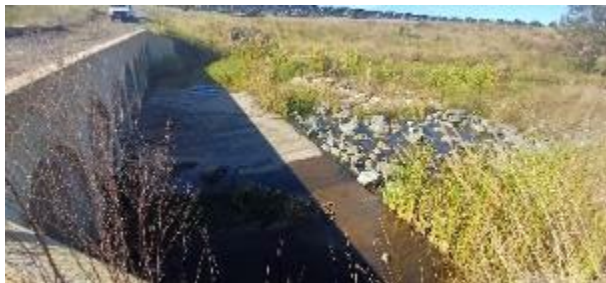
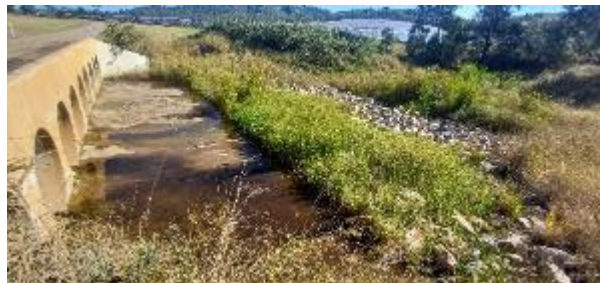
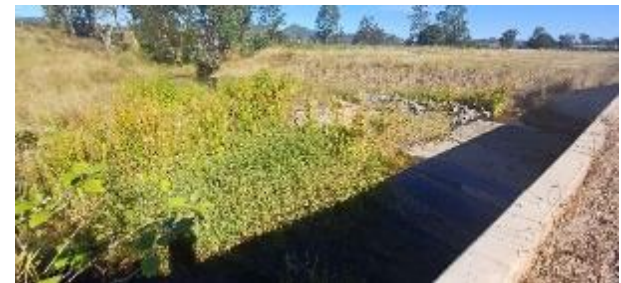
Plate 2 Culvert 2 WWBW conditions. Left to right showing culvert facing northeast; culvert facing southwest; and general condition of the waterway.

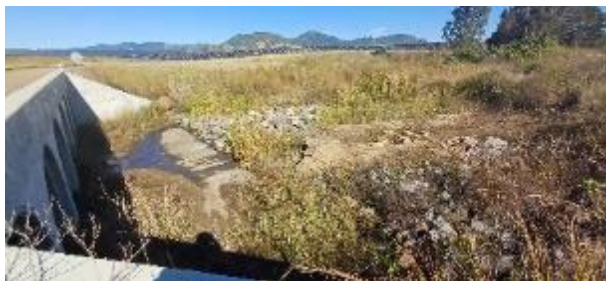
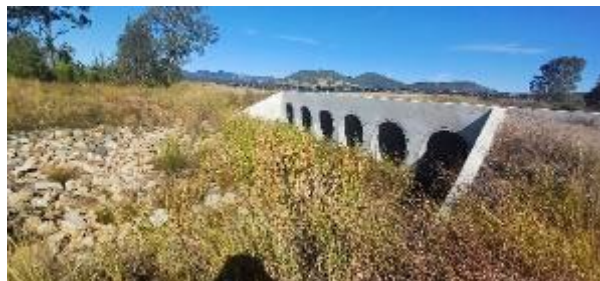
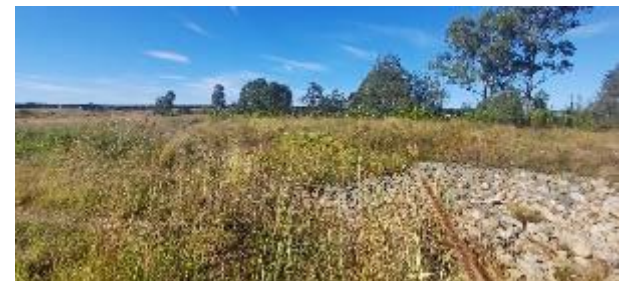
Plate 3 Culvert 3 WWBW conditions. Left to right showing culvert facing northeast; culvert facing southwest; and general condition of the waterway.

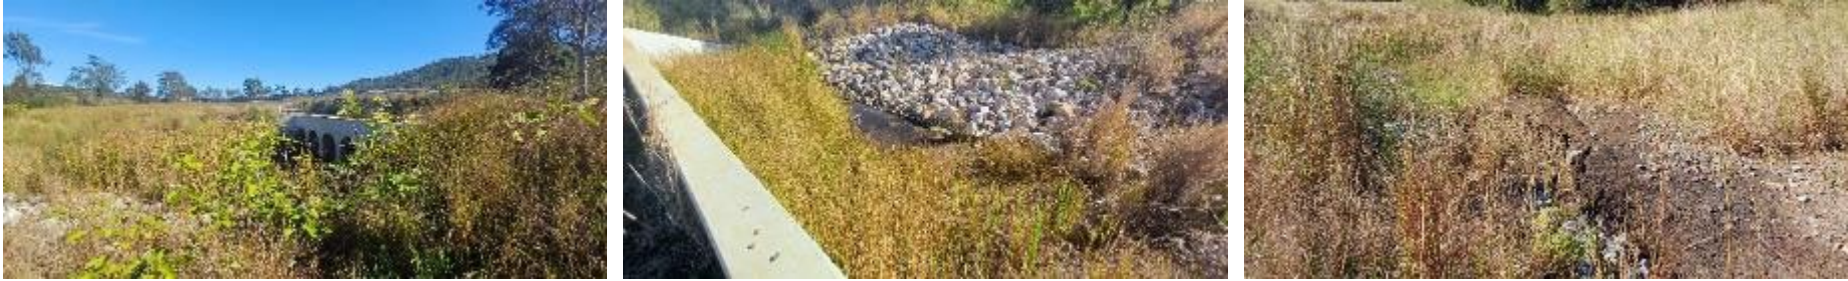
Plate 4 Culvert 4 WWBW conditions. Left to right showing culvert facing south; culvert facing north; and general condition of the waterway (washdown on bank).

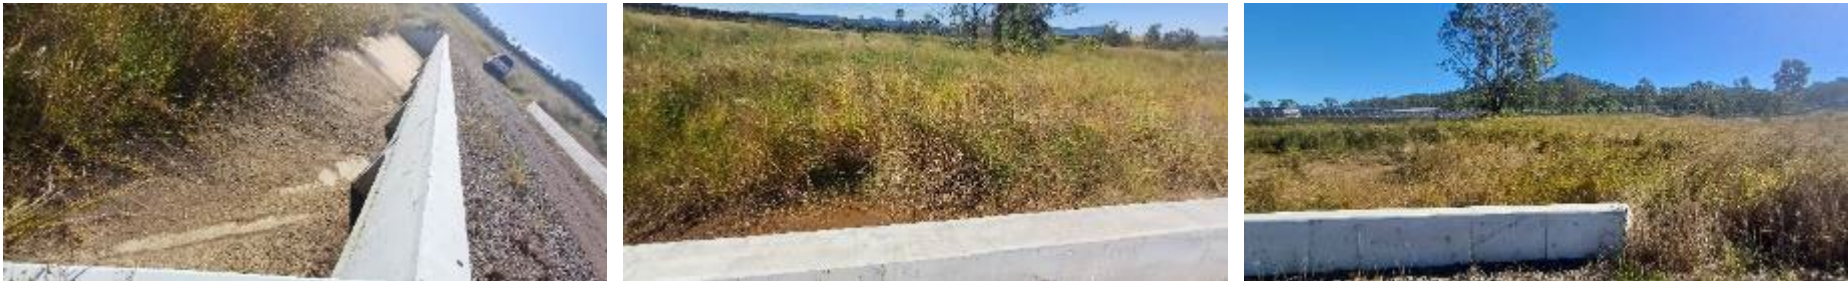
Plate 5 Culvert 5 WWBW conditions. Left to right showing culvert facing south; culvert facing north; and general condition of the waterway.

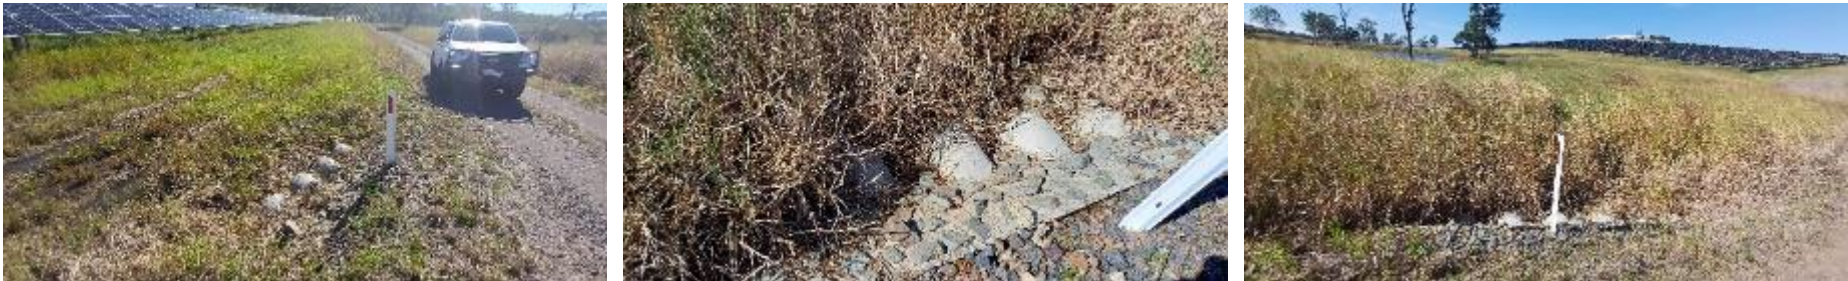
Plate 6 Culvert 6 WWBW conditions. Left to right showing culvert facing southwest; culvert facing north; and general condition of the waterway.

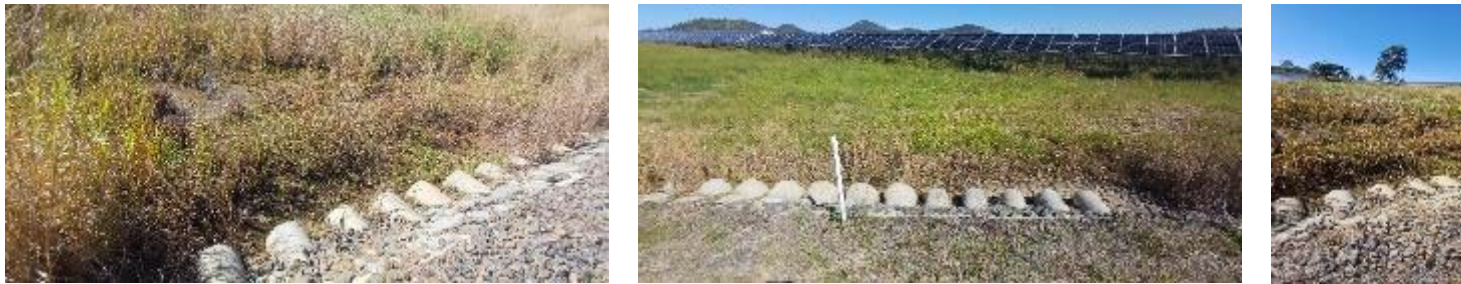
Plate 7 Culvert 7 WWBW conditions. Left to right showing culvert facing north; culvert facing south; and general condition of the waterway.

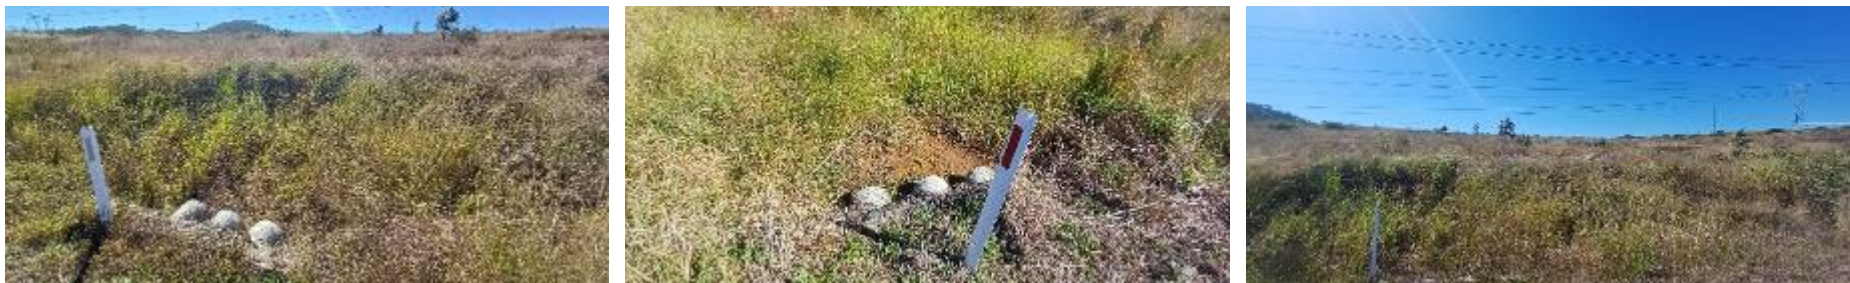
Plate 8 Culvert 8 WWBW conditions. Left to right showing culvert facing northeast; culvert facing south; and general condition of the waterway.

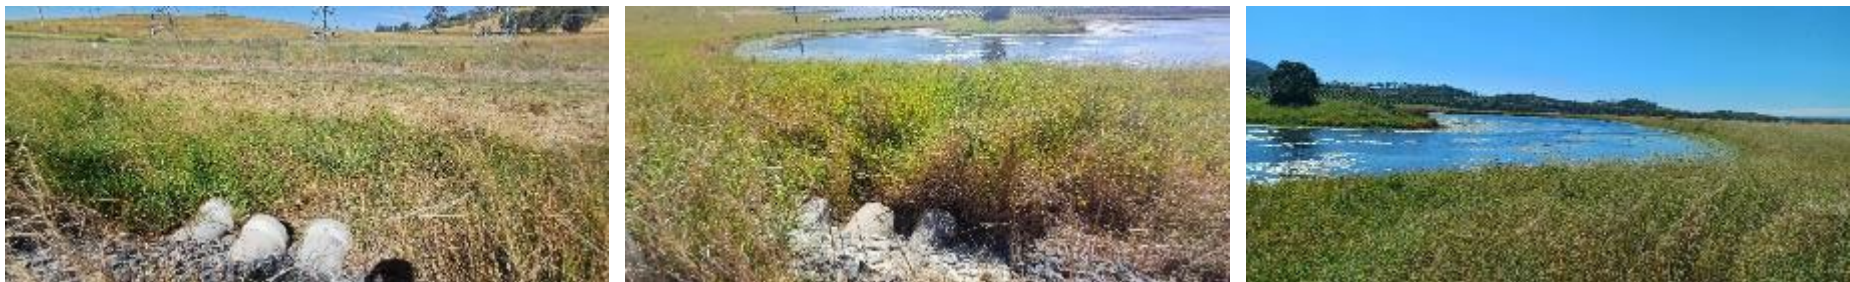
Plate 9 Culvert 9 WWBW conditions. Left to right showing culvert facing south; culvert facing north; and general condition of the waterway.

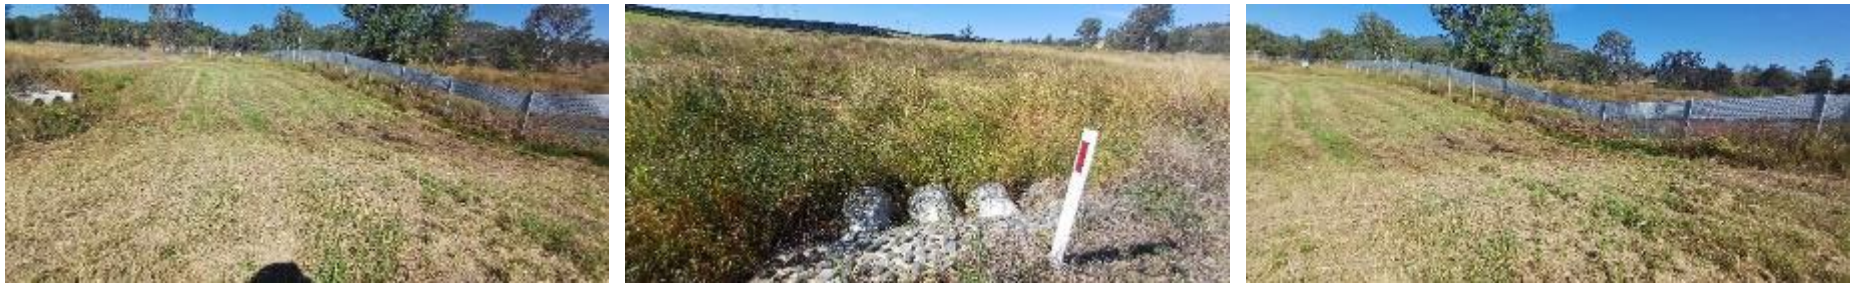
Plate 10 Culvert 10 WWBW conditions. Left to right showing culvert facing west; culvert facing northeast; and general condition of the waterway.

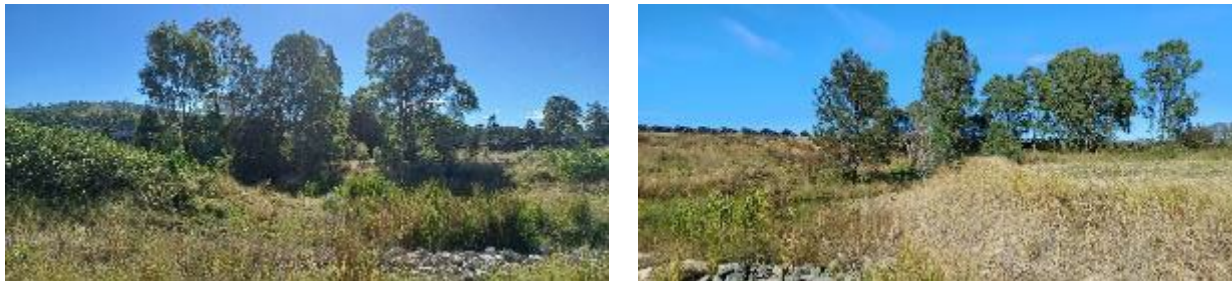
Location	Feature	Condition	General Audit Observations
Impacted area	Riparian corridor	General ecological status	<p>A generalized overgrowth of environmental weeds along the corridor was observed, hindering the natural regeneration of riparian vegetation on the banks of the waterway within the solar farm. Additionally, an overgrowth of <i>Typha sp.</i> was noted on the waterway bed at culvert 4. While <i>Typha sp.</i> naturally occurs in wetlands and waterways, its excessive growth obstructs fish passage, thereby impacting the ecological function of the waterway.</p> <p>Some areas of the northern branch, including around culvert 5, show recruitment of <i>Eucalyptus sp.</i>, and <i>Alphitonia excelsa</i>, which benefits wildlife shelter and habitat connectivity. Additionally, the southern branch ends in a lake next to the easement boundary. This lake contains open water with aquatic vegetation and a considerable number of wood ducks have been observed. Piles of timber from clearing activities during the construction phase have been placed near the lake, providing additional habitat for wildlife (Refer to Appendix C).</p>

Plate 11 Riparian corridor southeast from culvert 2. Left photo showing overgrowth of *Solanum mauritianum* and grasses within the corridor. Right photo showing native riparian canopy.

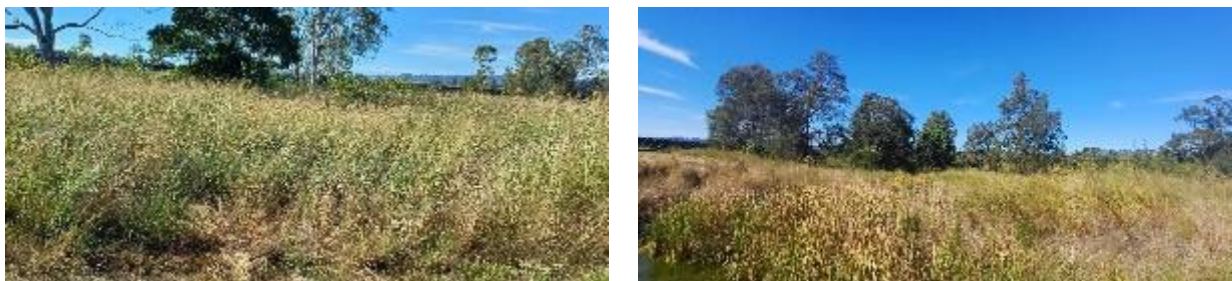
Plate 12 Riparian corridor south from culvert 4. Left photo shows *Chloris gayana* infestation. Right photo shows native riparian canopy.

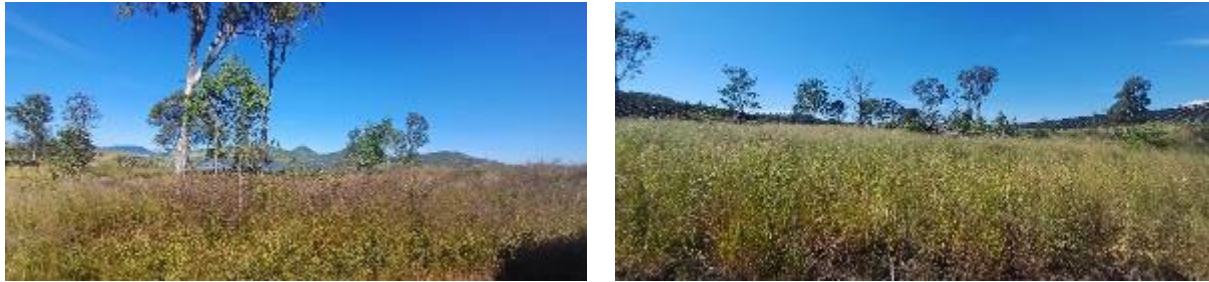
Plate 13 Riparian corridor at the north end of the north branch of the waterway within the solar farm. Left photo showing *Chloris gayana* infestation and native trees regrowth. Right photo shows grass infestation.

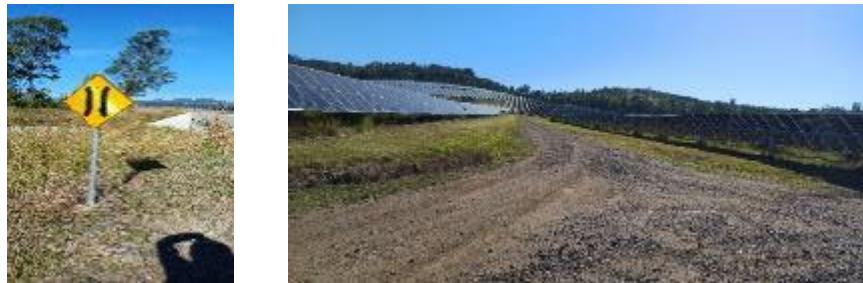
Plate 14 Traffic signalling within the solar farm premises. Left photo showing signalling at the waterway crossings. Right photo evidencing lack of speed limits or calming traffic measures on the roads.

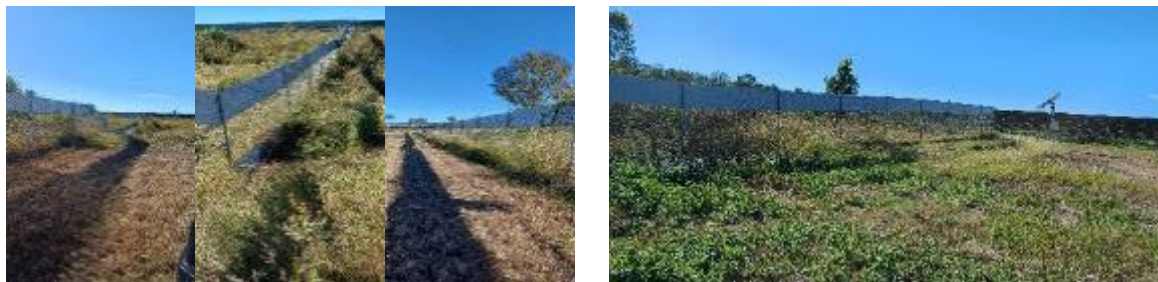
Plate 15 General good condition of the perimeter fencing. Photos show the koala exclusion panels along the northern boundary of the solar farm. Right photo shows evidence of effective corrective measures on previously reported fence damage (ACR1-Fence2).

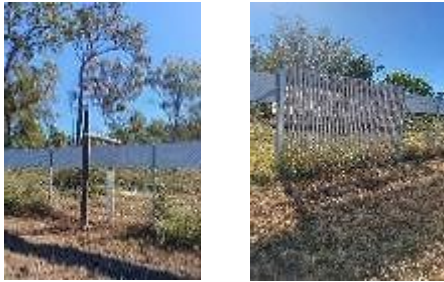
Plate 16 Fauna features on perimeter fence. Left photo shows koala pole crossings. Right photo evidence of a fauna grounding point.

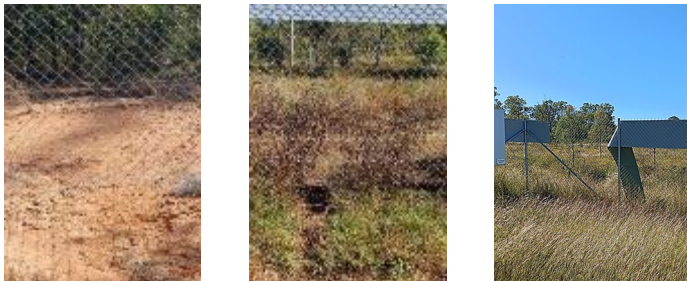
Plate 17 Fencing observations requiring corrective actions. Left photo evidence of a gaps between the fence and the ground. Middle photo evidence of a hole on the fence caused by fauna. Right photo evidence one loose exclusion fauna panel.

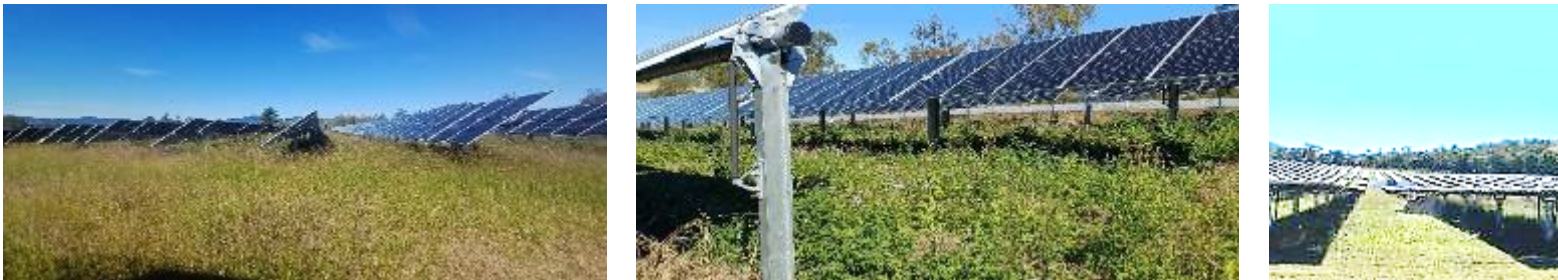
Plate 18 Weed management within the premises. Left photo evidence *Chloris gayana* overgrowth. Middle photo evidence billy goat weed overgrowth. Right photo shows ongoing maintenance works on site, consisting of mowing vegetation below panels.
