ANNUAL COMPLIANCE REPORT

**WOOLOOGA SOLAR FARM, LOWER WONGA
(EPBC 2019/8 554)**

PREPARED FOR: LIGHTSOURCE BP

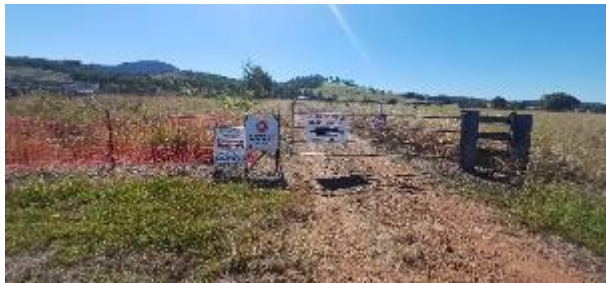
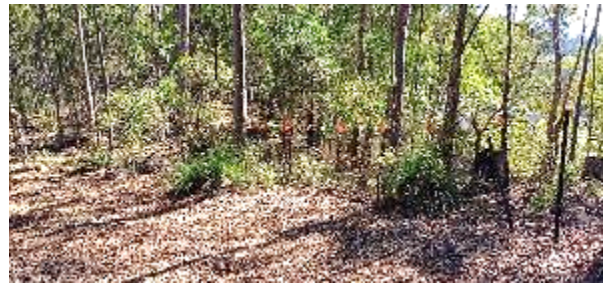
Plate 19 Access and fencing within offset area. Left photo shows the entry gate of the property. Right photo evidence of good condition of perimeter fencing and visibility tags.

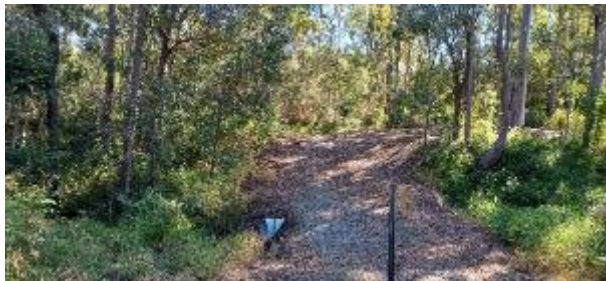
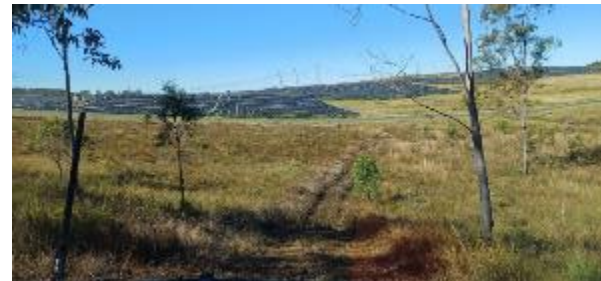
Plate 20 General conditions of fire trails and roads. Left photo evidence of water crossing management. Middle photo shows weed management on the tracks. Right photo evidence of good visibility and road conditions.

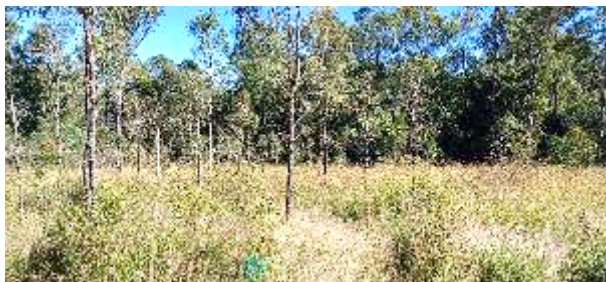
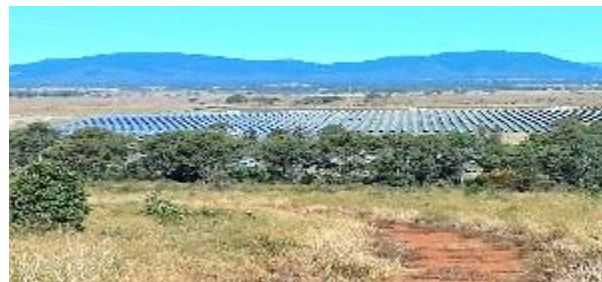
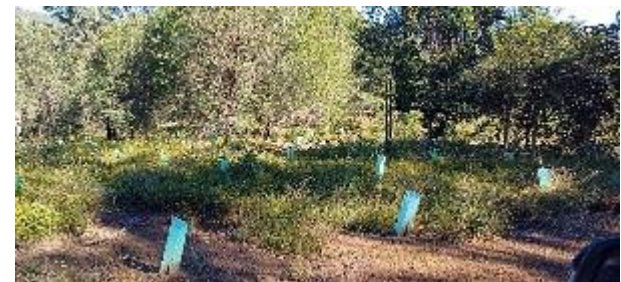
Plate 21 Designated planting areas general condition. Left photo evidence of canopy plantings established. Middle photo shows natural regeneration areas. Right photo evidence of most recent plantings with tree guards.

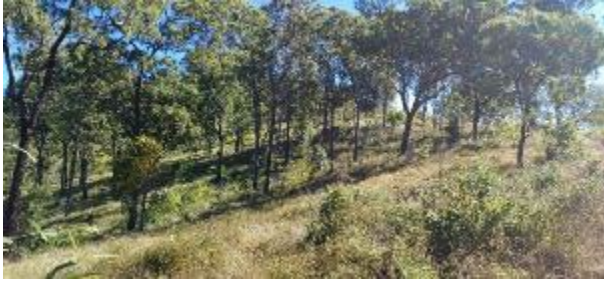
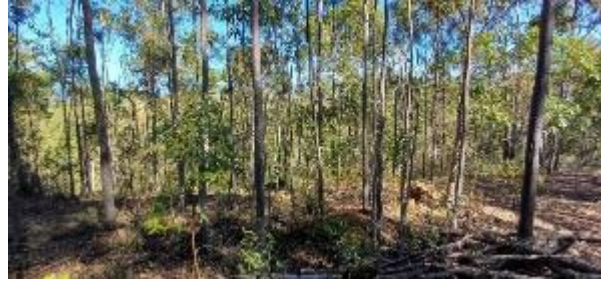
Plate 22 General conditions of natural regeneration zones (EMZ2) showing secondary growth of native vegetation

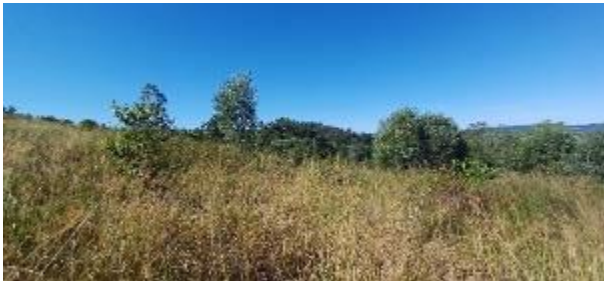
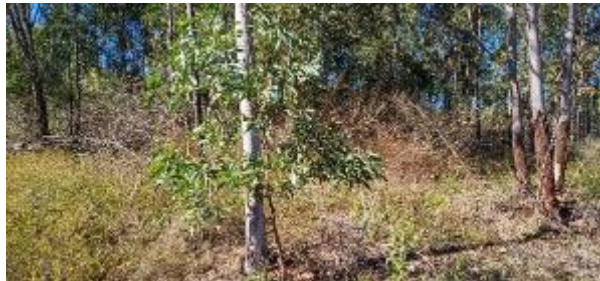
Plate 23 General observations about weed management. Left photo evidence of considerable overgrowth of Chloris gayana within planting zones. Right photo evidence of successful Lantana camara eradication.
