GOULBURN RIVER SOLAR FARM LANDSCAPE CHARACTER AND VISUAL IMPACT ASSESSMENT

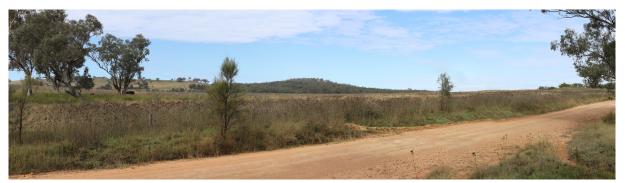
Figure 4-5: Proposed solar farm area viewed from Wollara Road, looking south-east

- A cleared area adjacent to Wollara Road (shown in Figure 4-5, Figure 4-6 and Figure 4-7)
- A large, cleared, centrally located area, of mostly elevated land (shown in Figure 4-8 and Figure 4-9) and
- An area in the north-east of the Project Area (shown in Figure 4-10).

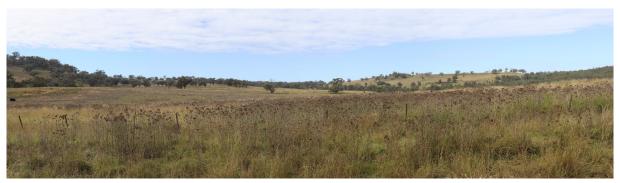
Figure 4-6: Proposed solar farm area viewed from Wollara Road, looking east

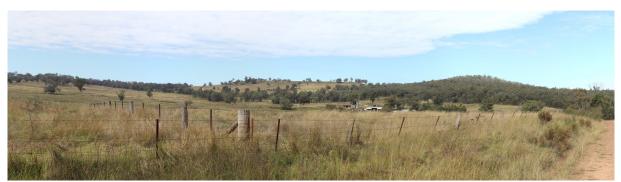
Figure 4-7: Proposed solar farm area and existing Post-War House, viewed from Wollara Road, looking south

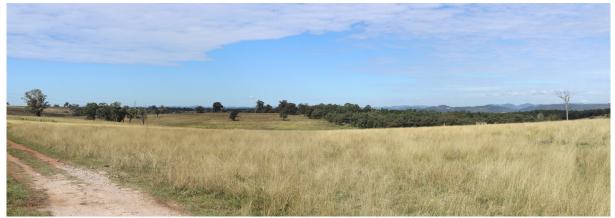
Figure 4-8: Proposed solar farm area on elevated, centrally located land within Project Area, looking south-east. The view includes the transmission line in the background

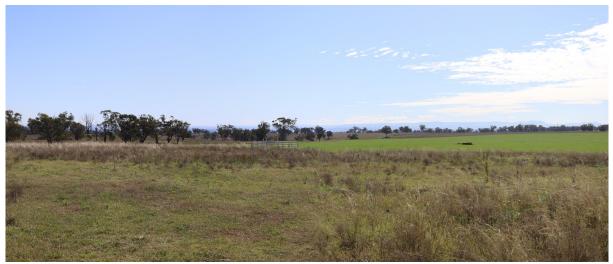
Figure 4-9: Proposed solar farm area on elevated, centrally located land within Project Area, looking north

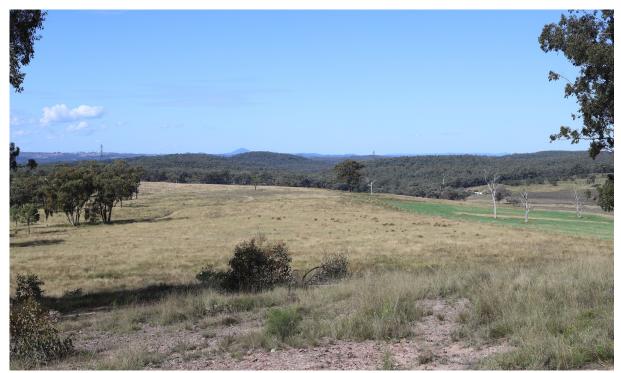
Figure 4-10: Proposed solar farm area in north-east of Project Area, looking south-east. The view includes the 1900s house and transmission line in background.

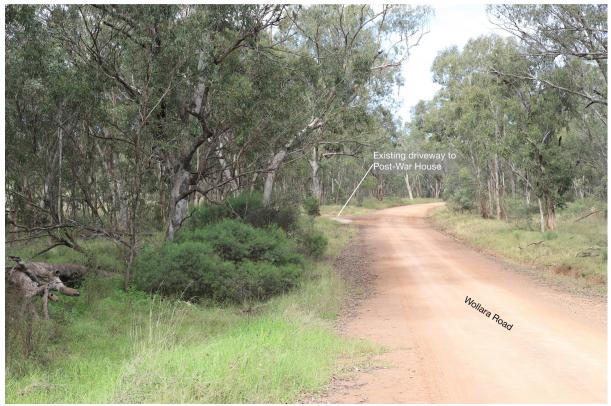
Figure 4-11: Location of existing main driveway off Wollara Road, looking south along Wollara Road

The main proposed entrance to the solar farm is from Wollara Road at an existing, unsealed driveway leading to the Post-War House. The existing driveway is partially screened by native trees within Wollara Road reserve and is shown in Figure 4-11.

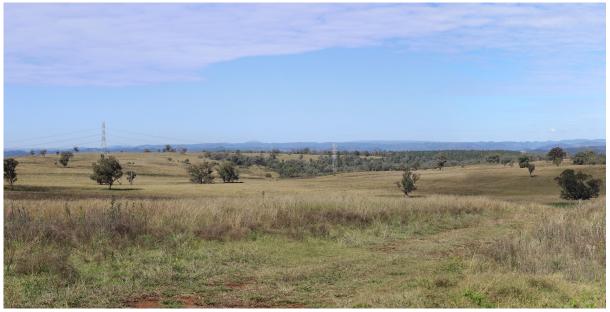
Figure 4-12: Existing transmission line passing through the Project Area, looking south-east

The proposed solar farm substation would be in the south-east of the Project Area near the existing transmission line. A view toward the existing transmission line passing through the south-east of the Project Area is shown Figure 4-12.

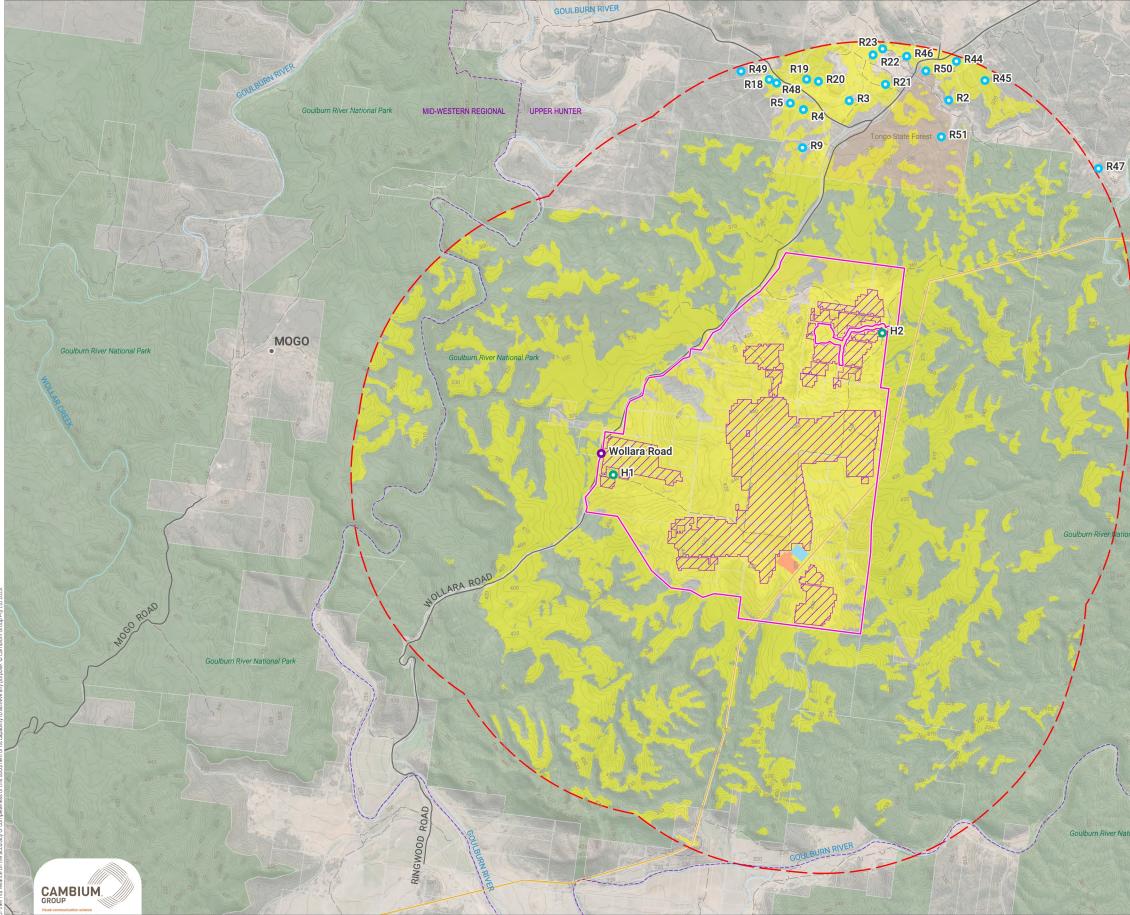
Figure 5-1 **Receivers and viewshed**

Potential private viewpoints (i.e., residences) within 4 km of the Project's development footprint, and public viewpoints from roads or rail within 2.5 km were initially identified. The locations are shown in Figure 5-1 and include nineteen residences and one public road (Wollara Road).

A viewshed of the proposed project based on 3 m height for the solar panels (the average height of the solar modules being between 2.6 - 2.98 m above ground level), was produced to determine whether the identified residences had a 'theoretical' line of sight to the Project. The Project's viewshed is shown in yellow in Figure 5-1. The viewshed was produced via geographic information systems (GIS) which account for topography and line of sight, but does not account for intervening elements such as vegetation or buildings which could obstruct views. Therefore, the projected direct line of sight is 'theoretical'.

Figure 5-1 shows that three potential viewpoints (receiver R2, R47 and R51) would not have 'theoretical' visibility to the Project. These receivers were eliminated from further analysis.
