**GOULBURN RIVER SOLAR FARM**

Soil, Land and Agriculture Assessment

April 2023

Project Director:	Malinda Facey
Project Manager:	Jessica Henderson-Wilson
Technical Project Director:	Malinda Facey
Technical Project Manager:	David McQueeney
Report No.:	21507/R12
Date:	April 2023

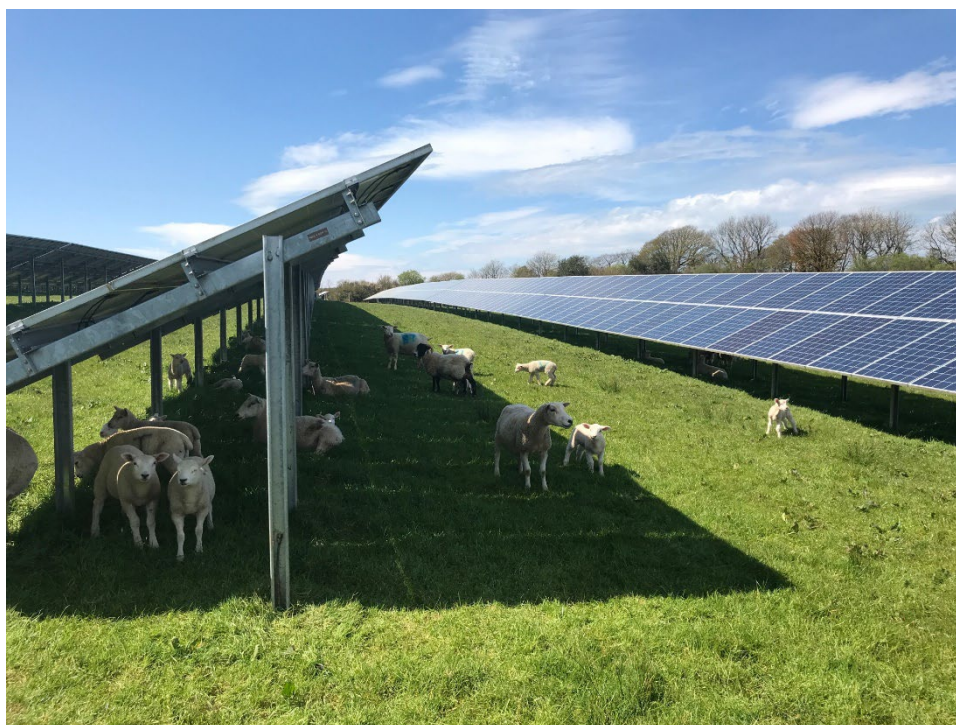
**Photo 1.1** Example of Dual Land Use

The Project will have an operational lifespan of 40 years. It is proposed that during the Project's operational life, the land could also support sheep grazing within the development footprint. This will be subject to the outcomes of a trial of sheep grazing. Refer to **Photo 1.1** for an example of co-habitation of a solar farm development and sheep grazing.

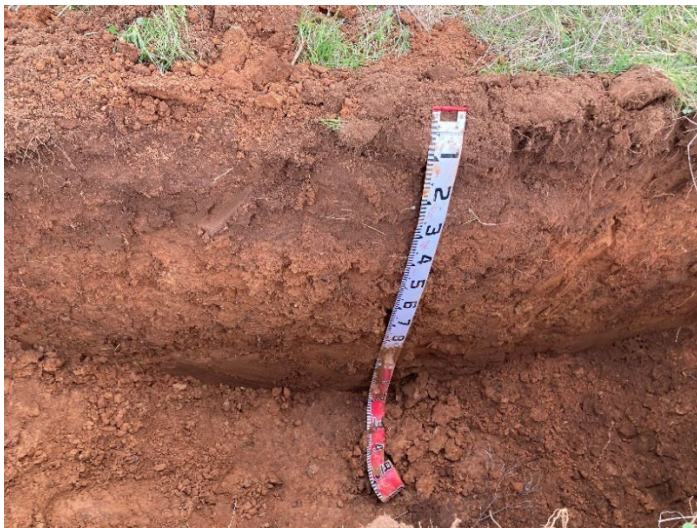
**Photo 7 – Soil Profile**

Description: Site 2 (GR02)										
Site Reference	GR02		ASC Name	Petroferric Eutrophic Brown Dermosols (mapped as Dermosols)			Coordinates			
Average Slope	Gently Inclined (5%)		Soil Fertility	Low			Lat: -32.282808	Lon: 150.078611		
Land Use	Agriculture (grazing)		LSC Class	4			General observations			
Landform Element	Hillslope		Micro-Relief	None			Pasture used for open grazing with mix of improved pasture and native vegetation. No pan and 100% ground cover observed.			
Surface Condition	100% ground cover		Vegetation	Native and improved pastures						
Soil Horizon:	Depth (m)	Description								
A1	0.0-0.15	Munsell Colour: very dark brown (7.5YR 2.5/3), silty with granular structure, low firmness, and strength. Not sticky and low plasticity. Low percentage of coarse fragments and roots present. Moist, free drainage with loose to medium consistency. Non saline, slightly sodic and dispersion can only occur under raindrop impact in surface soils, slightly dispersive, strongly acidic pH and moderate CEC.

B1	0.15 -0.7	Munsell colour: strong brown (7.5YR 3/4) clayey silt with massive structure, firm, and strong, low stickiness, medium plasticity. Low percentage of coarse fragments and some roots detected. Moist and medium consistency. Non saline, slightly sodic, moderately dispersive, slightly alkaline pH and moderate CEC.								
B2	0.7 – 1.2	Brown to grey, red, silty clay with massive structure, mottled and gleying. Firm, strong, low stickiness, medium plasticity. Low level of basalt fragments and no roots detected. Moist and poor drainage. No sample.								
Key Results of Analysis										
Sample Depth	ECe		ESP		EAT		pH <sub>(1-5water)</sub>		CEC	
	dS/m	Rating	Value	Rating	Value	Rating	Value	Rating	Value	Rating
0–0.1	0.033	Non-saline	3.1	Slightly sodic	3	Slightly dispersive	5.45	Strongly Acid	6.4	Moderate

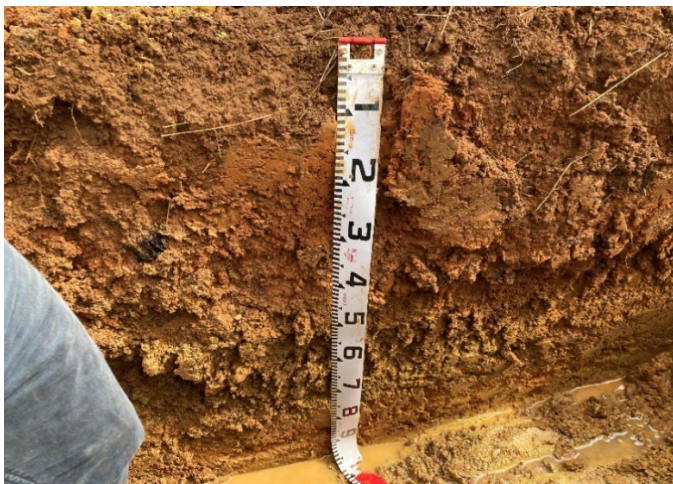
Photo 11 – Soil Profile

Description: Site 3 (GR03)										
Site Reference	GR03	ASC Name	Humose Mottled Dermosol (mapped as Dermosols)				Coordinates			
Average Slope	Sloped (9%)	Soil Fertility	Low				Lat: -32.284563	Lon: 150.082354		
Land Use	Agriculture (grazing)	LSC Class	6				General observations			
Landform Element	Hillslope	Micro-Relief	None				Pasture used for open grazing with mix of improved pasture and native vegetation.			
Surface Condition	100% ground cover	Vegetation	Native and improved pastures							
Soil Horizon:	Depth (m)	Description								
A1	0.0-0.1	Munsell Colour: Dark brown (7.5YR 3/4), coarse sandy silt, low firmness and strength with some stickiness and low plasticity. Low levels of fine gravel and roots detected. Moist, well drained, and loose consistency. Non-saline, sodic, slightly dispersive, moderately acid pH, and low CEC.								
A2	0.1-0.2	Munsell Colour: Strong brown (7.5YR 4/6), silty clay with massive structure, firm and strong with medium plasticity with some stickiness. Some small stone fragments and low level of roots detected. Moist, poor drainage, and rigid consistency. Non-saline, sodic, moderately dispersive, slightly acid pH, and moderate CEC.

0.0-0.1	0.041	Non-saline	6.6	Sodic	3	Slightly dispersive	5.63	Moderately Acid	5	Low
0.1-0.2	0.038	Non-saline	8.1	Sodic	2	Moderately dispersive	6.23	Slightly Acid	5.6	Moderate

0.4-0.5	0.114	Non-saline	26	Strongly Sodic	2	Moderately dispersive	8.65	Moderately Alkaline	11	Moderate

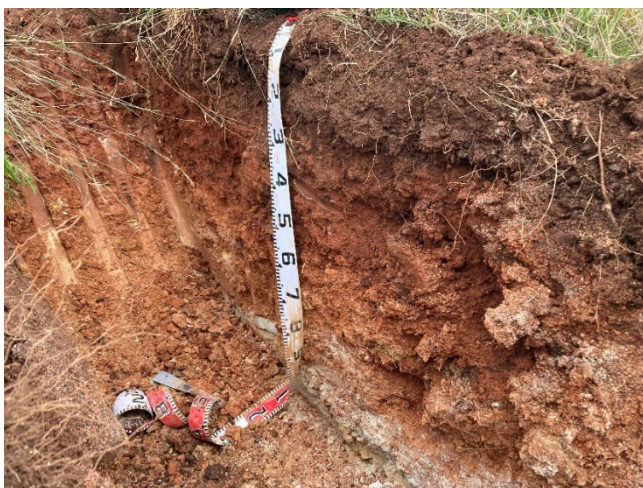
**Photo 15 – Soil Profile**

Description: Site 4 (GR04)										
<b>Site Reference</b>	GR04		<b>ASC Name</b>	Petroferric Eutrophic Red Dermosol			<b>Coordinates</b>			
<b>Average Slope</b>	Sloped (15%)		<b>Soil Fertility</b>	High			<b>Lat:</b> -32.288633	<b>Lon:</b> 150.083317		
<b>Land Use</b>	Agriculture (grazing)		<b>LSC Class</b>	6			<b>General observations</b>			
<b>Landform Element</b>	Maximum upper slope		<b>Micro-Relief</b>	None			100% grazing grass vegetation cover with open grazing near roadway. Hilly area.			
<b>Surface Condition</b>	100% ground cover		<b>Vegetation</b>	Native and improved pastures						
<b>Soil Horizon:</b>	<b>Depth (m)</b>	<b>Description</b>								
<b>A1</b>	0.0-0.1	Munsell Colour: Dark reddish brown (5YR 3/2), silt with granular structure, low firmness and strength, with no stickiness or plasticity. High levels of basalt rock fragments and roots detected. Moist, free drainage, and loose consistency. Non-saline, non-sodic, slightly dispersive, moderately acid pH, and high CEC.

<b>B1</b>	0.2-0.3	Munsell Colour: Yellowish red (5YR 4/6), clay with massive structure, high firmness and strength and sticky with high plasticity. Fine to medium rock fragments and low levels of roots detected. Moist, poor drainage with rigid consistency. Non-saline, non-sodic, negligible dispersiveness, moderately alkaline pH, and high CEC.								
<b>B2</b>	0.6-0.9	Light red with grey sandstone and massive structure, clay with weathered rock, medium strength and medium to high firmness. Low stickiness and plasticity. Nil roots detected and weathered rock fragments approx. 10mm detected. Moist and medium consistency. No sample.								
Key Results of Analysis										
Sample Depth	ECe		ESP		EAT		pH <sub>(1.5water)</sub>		CEC	
	dS/m	Rating	Value	Rating	Value	Rating	Value	Rating	Value	Rating
<b>A1</b>	0.100	Non-saline	2	Non sodic	3	Slightly dispersive	5.72	Moderately Acid	19	High
<b>B1</b>	0.174	Non-saline	2	Non sodic	4	Negligible / aggregated	8.25	Moderately Alkaline	47	High

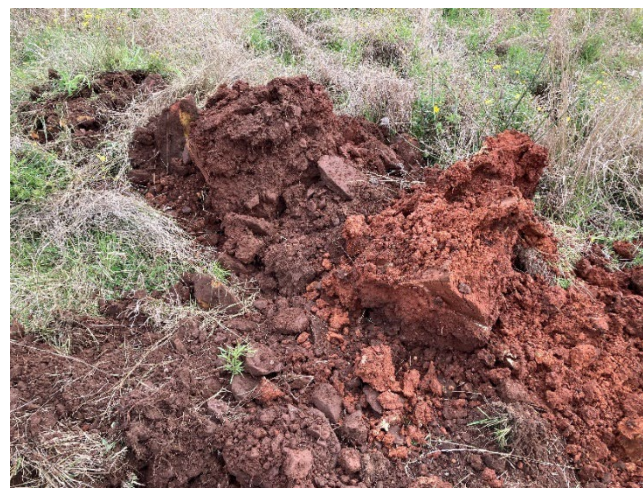
**Photo 16 – Excavated soil showing high rock content**

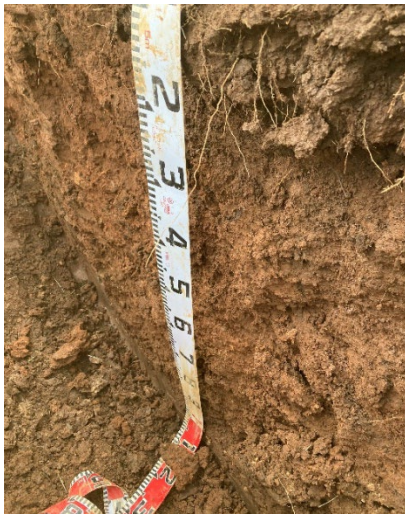
**Photo 19 – Soil Profile**

Description: Site 5 (GR05)										
Site Reference	GR05		ASC Name	Brown Petroferic Eutrophic Ferric Sodic Dermosol			Coordinates			
Average Slope	Gently Inclined (6%)		Soil Fertility	High			Lat: -32.295364	Lon: 150.088590		
Land Use	Agriculture (grazing)		LSC Class	4			General observations			
Landform Element	Rolling, undulating hill		Micro-Relief	None			Good vegetation cover with some surface rock			
Surface Condition	100% ground cover.		Vegetation	Native and improved pastures						
Soil Horizon:	Depth (m)	Description								
A1	0.0-0.1	Munsell Colour: Very dark brown (7.5YR 2.5/3), silty loam with massive structure, low firmness and strength with no stickiness or plasticity. Large gravel fragments present and high level of roots detected. Moist, free drainage and loose consistency. Non-saline, slightly sodic and dispersion can only occur under raindrop impact in surface soils, slightly dispersive, slightly acid pH, and high CEC.

B1	0.2-0.32	Munsell Colour: Dark reddish brown (5YR 3/4), loose clay with massive structure, very firm and very strong and rigid with medium stickiness and plasticity. Gravel fragments throughout increasing with depth and some roots detected. Moist, medium drainage and rigid consistency. Non-saline, sodic, slightly dispersive, moderately alkaline pH, and high CEC.								
B2	0.9-1.1	Light brown, firm gravely clay with massive structure, high firmness and strength, sticky with high plasticity. High levels of basalt gravel fragments and nil roots detected. Moist, free drainage, and rigid consistency. No sample.								
Key Results of Analysis										
Sample Depth	ECe		ESP		EAT		pH <sub>(1-5water)</sub>		CEC	
	dS/m	Rating	Value	Rating	Value	Rating	Value	Rating	Value	Rating

0.0-0.1	0.054	Non-saline	3.2	Slightly sodic	3	Slightly dispersive	6.48	Slightly Acid	26.6	High
0.2-0.3	0.067	Non-saline	8.5	Sodic	3	Slightly dispersive	8.25	Moderately Alkaline	39.7	High

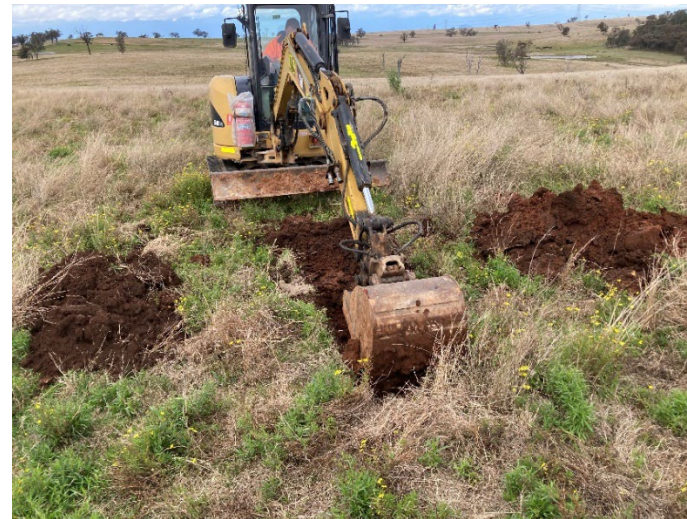
**Photo 20 – Excavated soil material**
