**Plant Community Types in
Solar Farm Development
Footprint**

Threatened Ecological Communities in Solar Farm Development Footprint

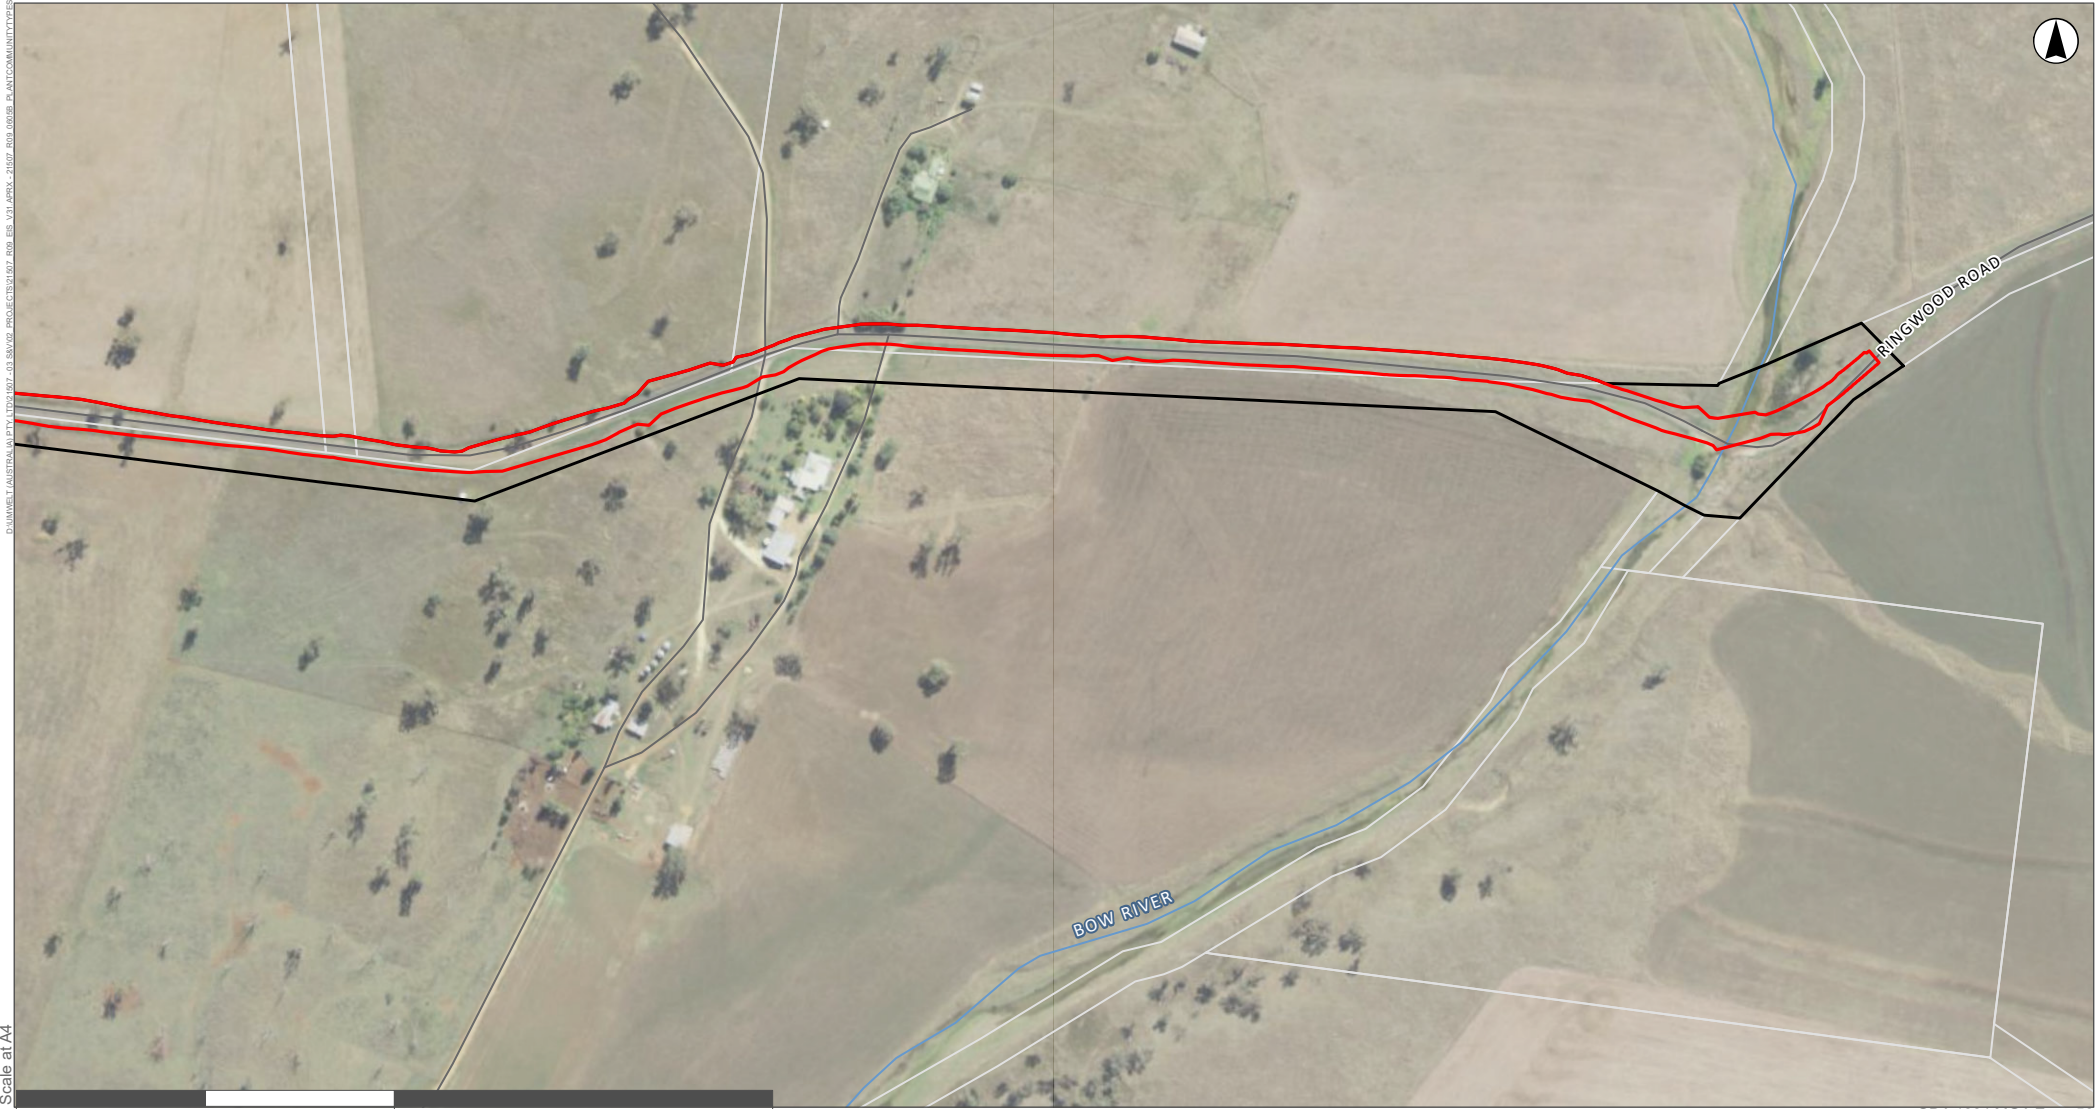
FIGURE 6.5 B
Plant Community Types in the Road Repairs and Upgrades Area

- Legend**
- Road
 - Watercourse
 - Property Boundaries
 - Road Repairs and Upgrades Area
 - Project Area (as defined in the BDAR)
- Plant Community Types**
- PCT 483 Condition Zone 1 Remnant Woodland (0.055 ha)
 - PCT 483 Condition Zone 2 Exotic Dominated Grassland (2.069 ha)
 - Cleared Land (1.464 ha)

Surveys of the Road Repairs and Upgrades area identified one PCT which has been split into two native vegetation zones based on condition types. Details of the vegetation zones and associated PCTs are listed below, summarised in **Table 6.6** and illustrated in **Figure 6.5**.

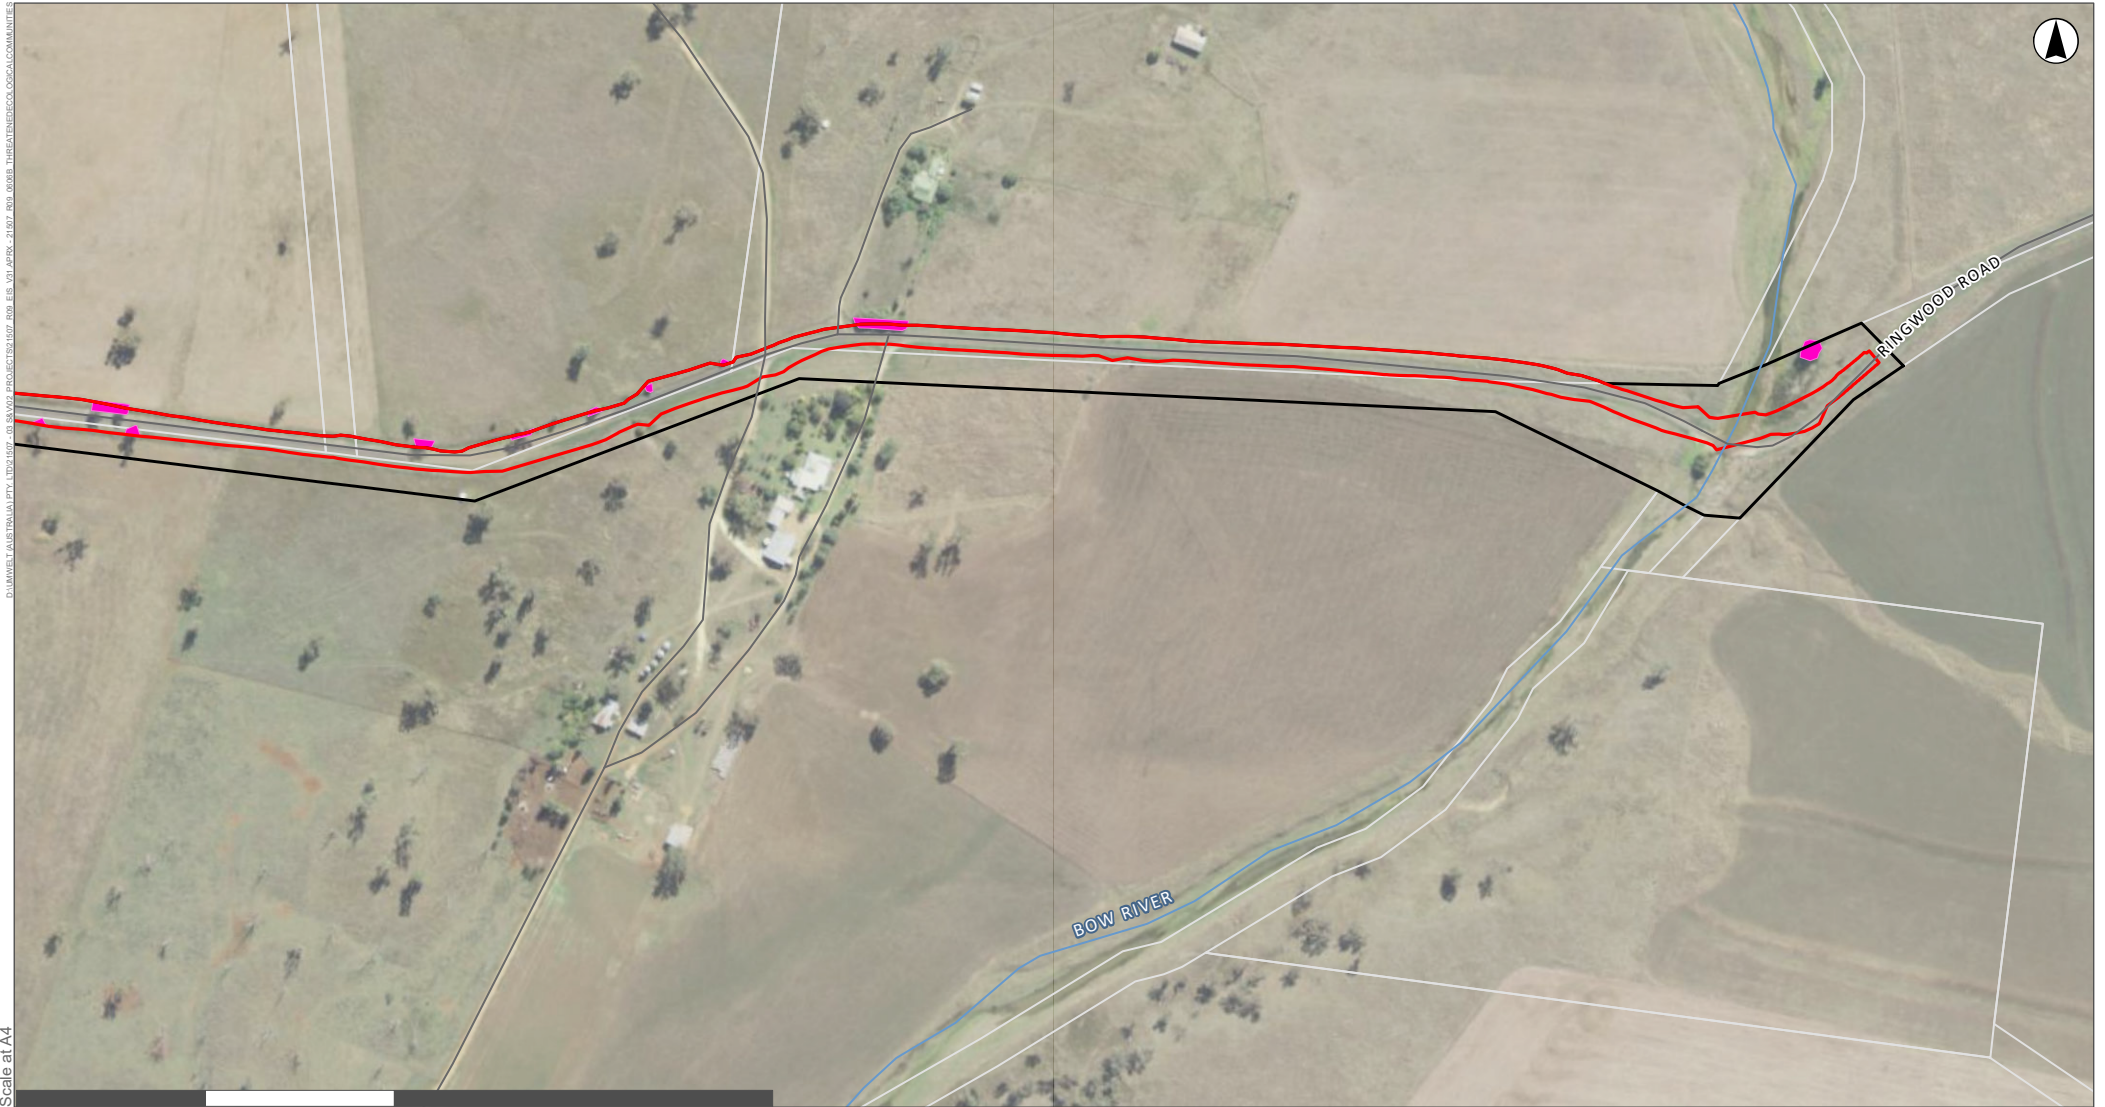
FIGURE 6.6 B
Threatened Ecological Communities
in Road Repairs and Upgrades Area

- Legend
- Road
 - Watercourse
 - Property Boundaries
 - ▭ Road Repairs and Upgrades Area
 - ▭ Project Area (as defined in the BDAR)
 - BC Act TEC - White Box - Yellow Box - Blakely's Red Gum Grassy Woodland and Derived Native Grassland CEEC
