Lightsource BP  
Project Maen Hir – South B  
Anglesey  
Phase 1 Geo-Environmental Assessment

July 2024

<b>Document Number:</b>	MSF-BWB-ZZ-XX-RP-YE-0003_Ph1-South B
<b>BWB Reference:</b>	232062

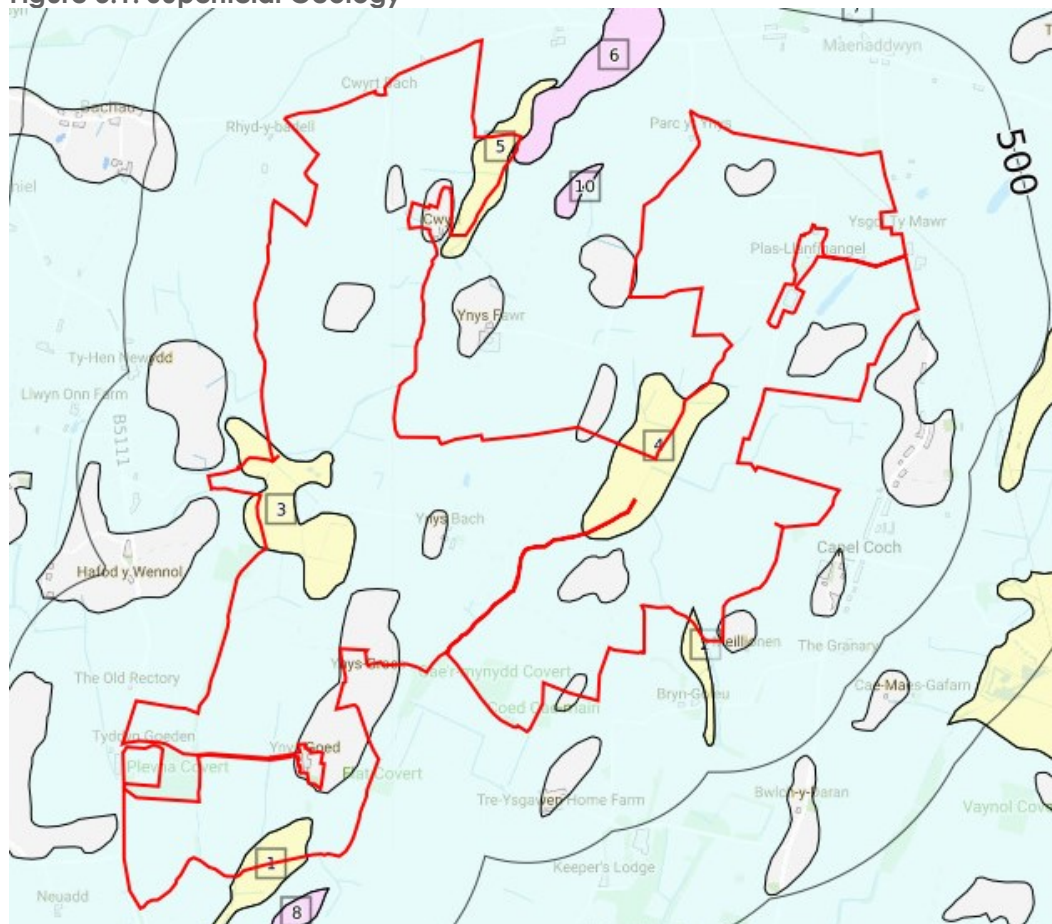
**Figure 3:1: Superficial Geology**

3.3 Information published by the BGS indicates that a large proportion of the site is underlain by Devensian Till superficial deposits, indicated by the pale blue areas on **Figure 3:1** below. Localised pockets of Alluvium (clay, silt, sand and gravel) are mapped adjacent to the water courses in the north, west, south west and central areas (yellow areas). Glaciofluvial Deposits (sand and gravel) are mapped partially overlapping the northern site boundary (pink areas). Superficial deposits are locally absent across the site.

- 8.3 Ground conditions are anticipated to comprise Devensian Till and localised Alluvium overlying bedrock of the Coedana Granite/Complex, undifferentiated Central Anglesey Shear Zone and Berw Shear Zone, and Ordovician Rocks. Igneous intrusions are mapped in the south west and west of the site, with a fault mapped in the north west of site, trending in a north to south direction. Localised Made Ground is expected in the vicinity of infilled ponds and quarries.
