# ANNUAL COMPLIANCE REPORT

# WOOLOOGA SOLAR FARM, LOWER WONGA (EPBC 2019/8 554)

PREPARED FOR: LIGHTSOURCE BP

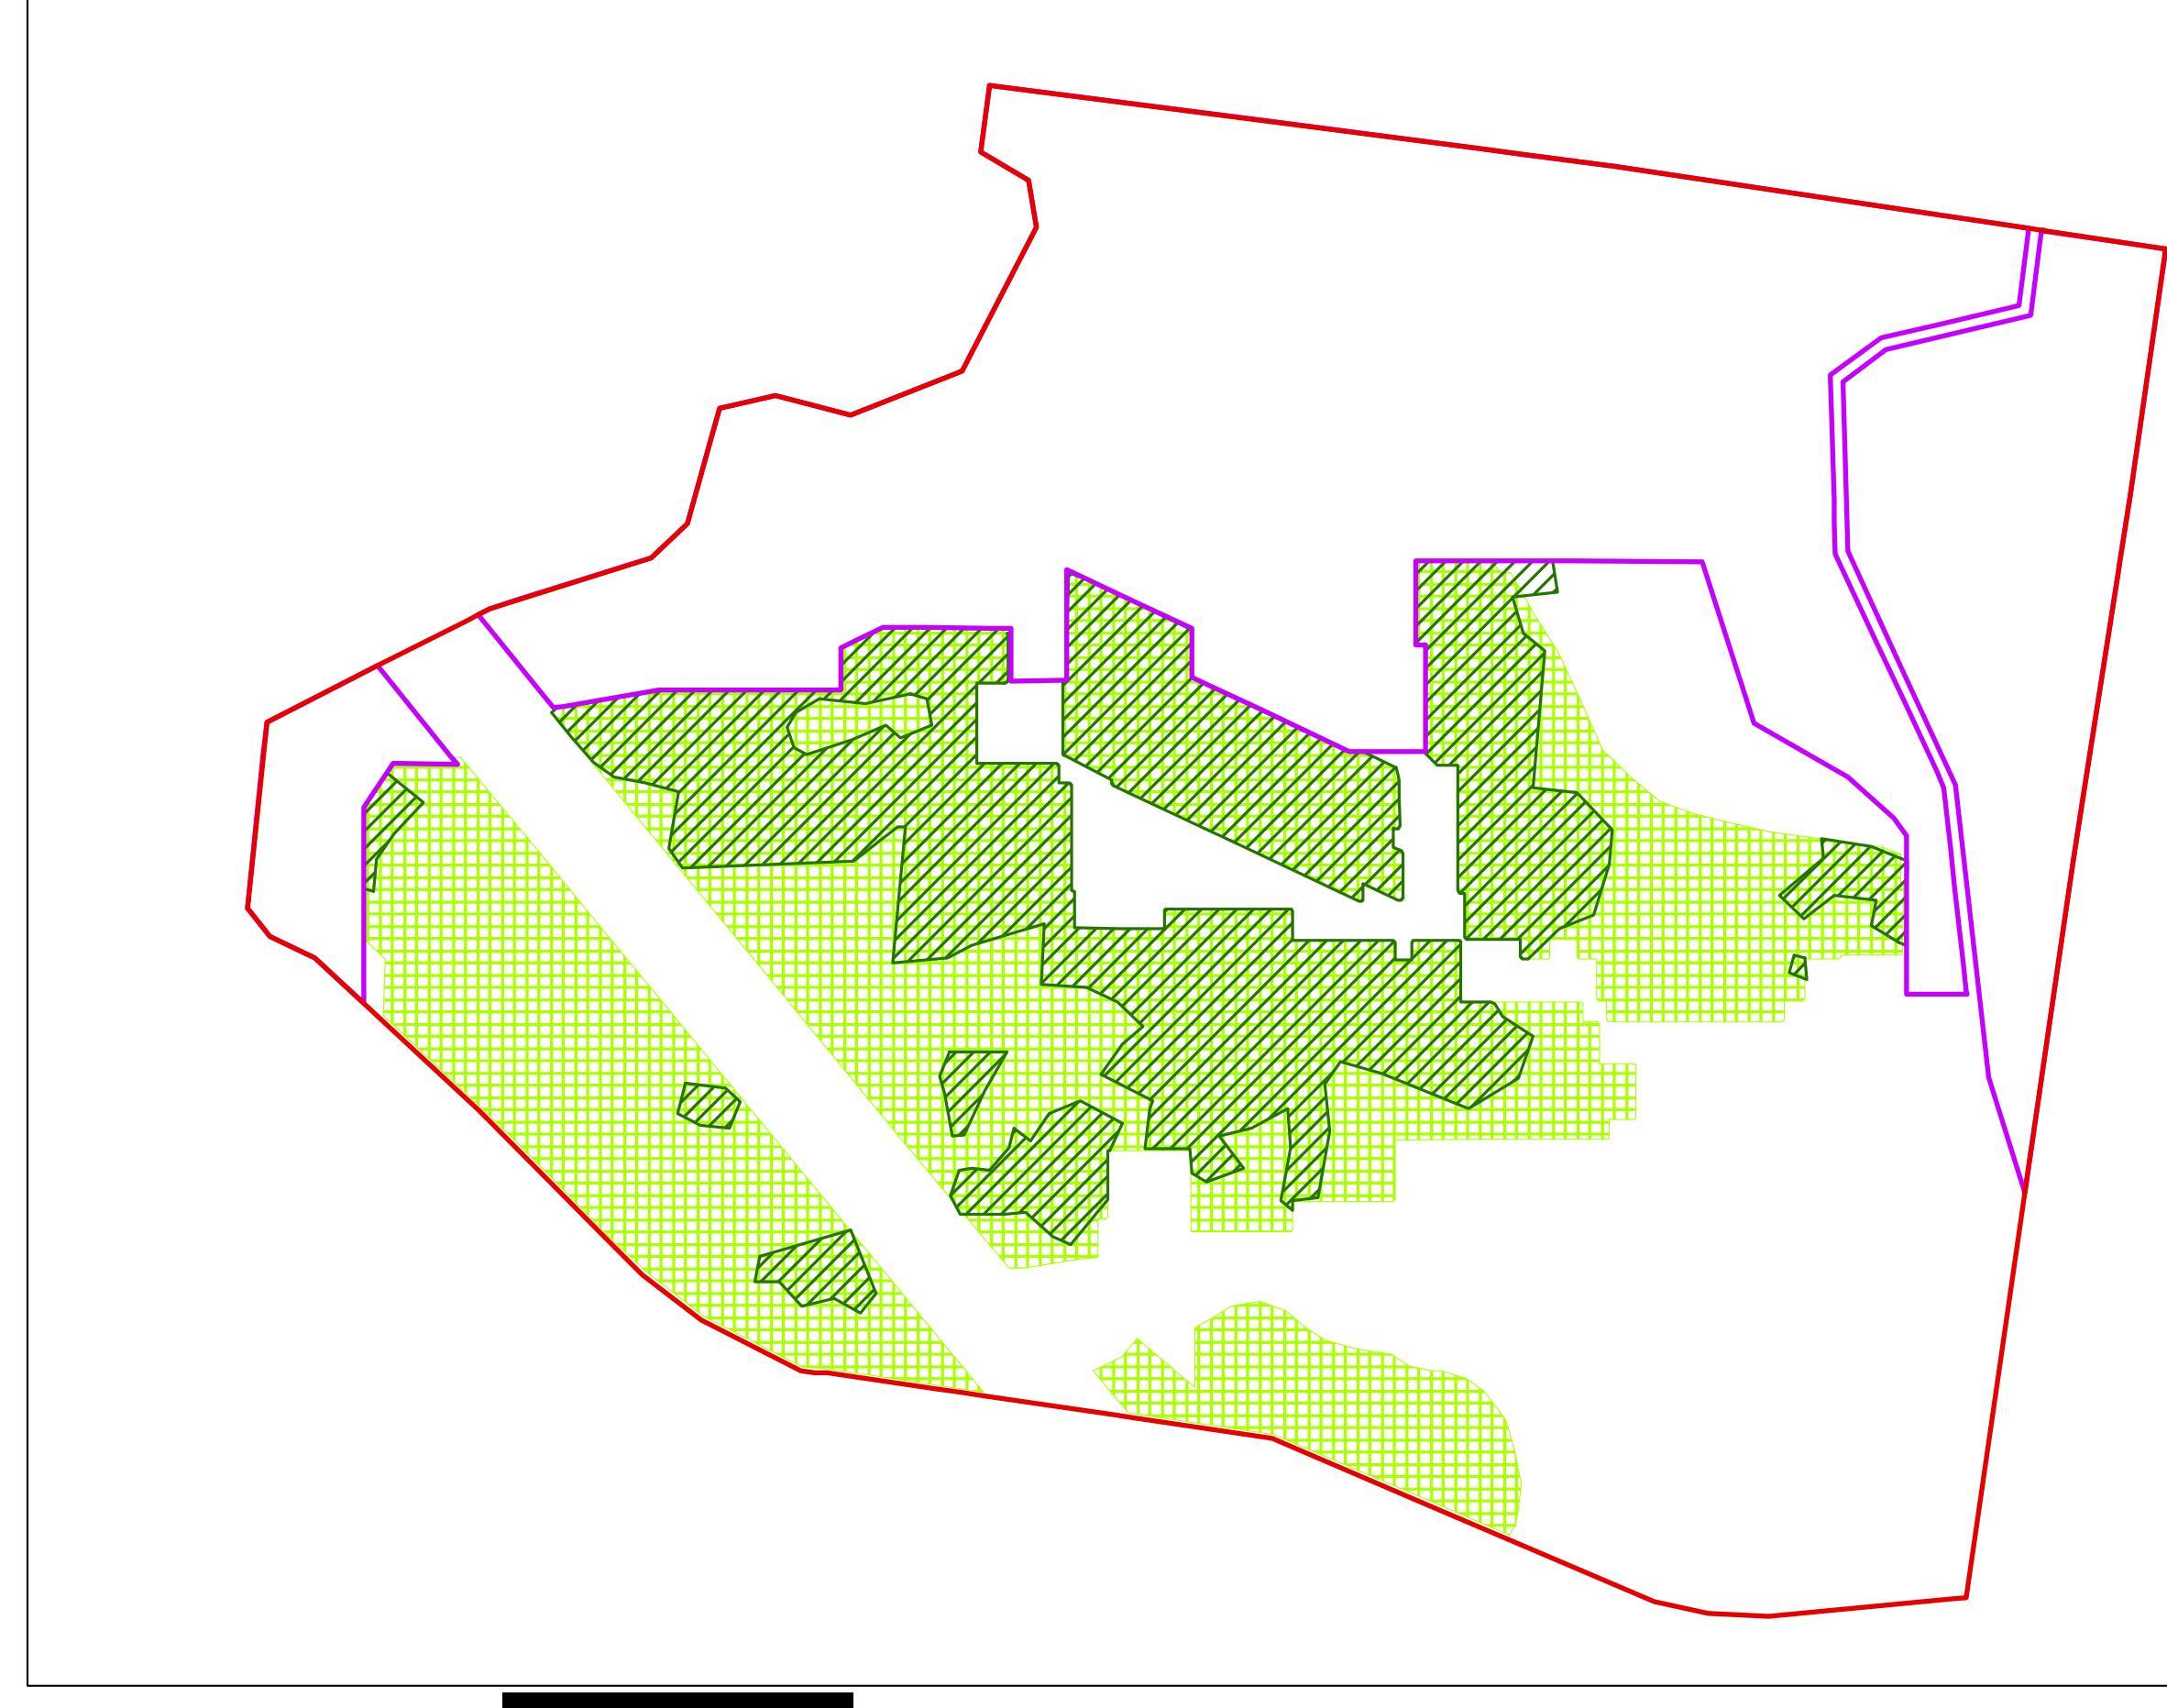
# Plan 1. Koala and GHFF Habitat Impact

# Project Area Offset Area GHFF habitat impact areas (79.8 ha) Koala habitat impact areas (172.2 ha) Ν

No.	Condition	Compliance	Evidence/comments		
Part A	Part A - Development area				
1	The approval holder must not clear more than 176 ha of Koala habitat and 83.38 ha of Grey-headed Flying-fox foraging habitat within the development area; and must confine any clearing of Koala habitat to the areas shaded in hatched green identifying Koala habitat, as shown in Attachment A; and any clearing of Grey-headed Flying-fox foraging habitat to the areas shaded in hatched blue identifying Grey-headed Flying-fox habitat, as shown in Attachment B.	Compliant	172.2 ha of Koala habitat (confined to areas shaded in hatched green identifying Koala habitat, Attachment A in approval), and 79.8 ha of GHFF foraging habitat (confined to areas shaded in hatched blue, Attachment B in approval) has been cleared. Evolve conducted a site inspection on the 20 <sup>th</sup> of May 2022 and can confirm the areas for retention have not been cleared of habitat. Refer <b>Plan 1</b> .

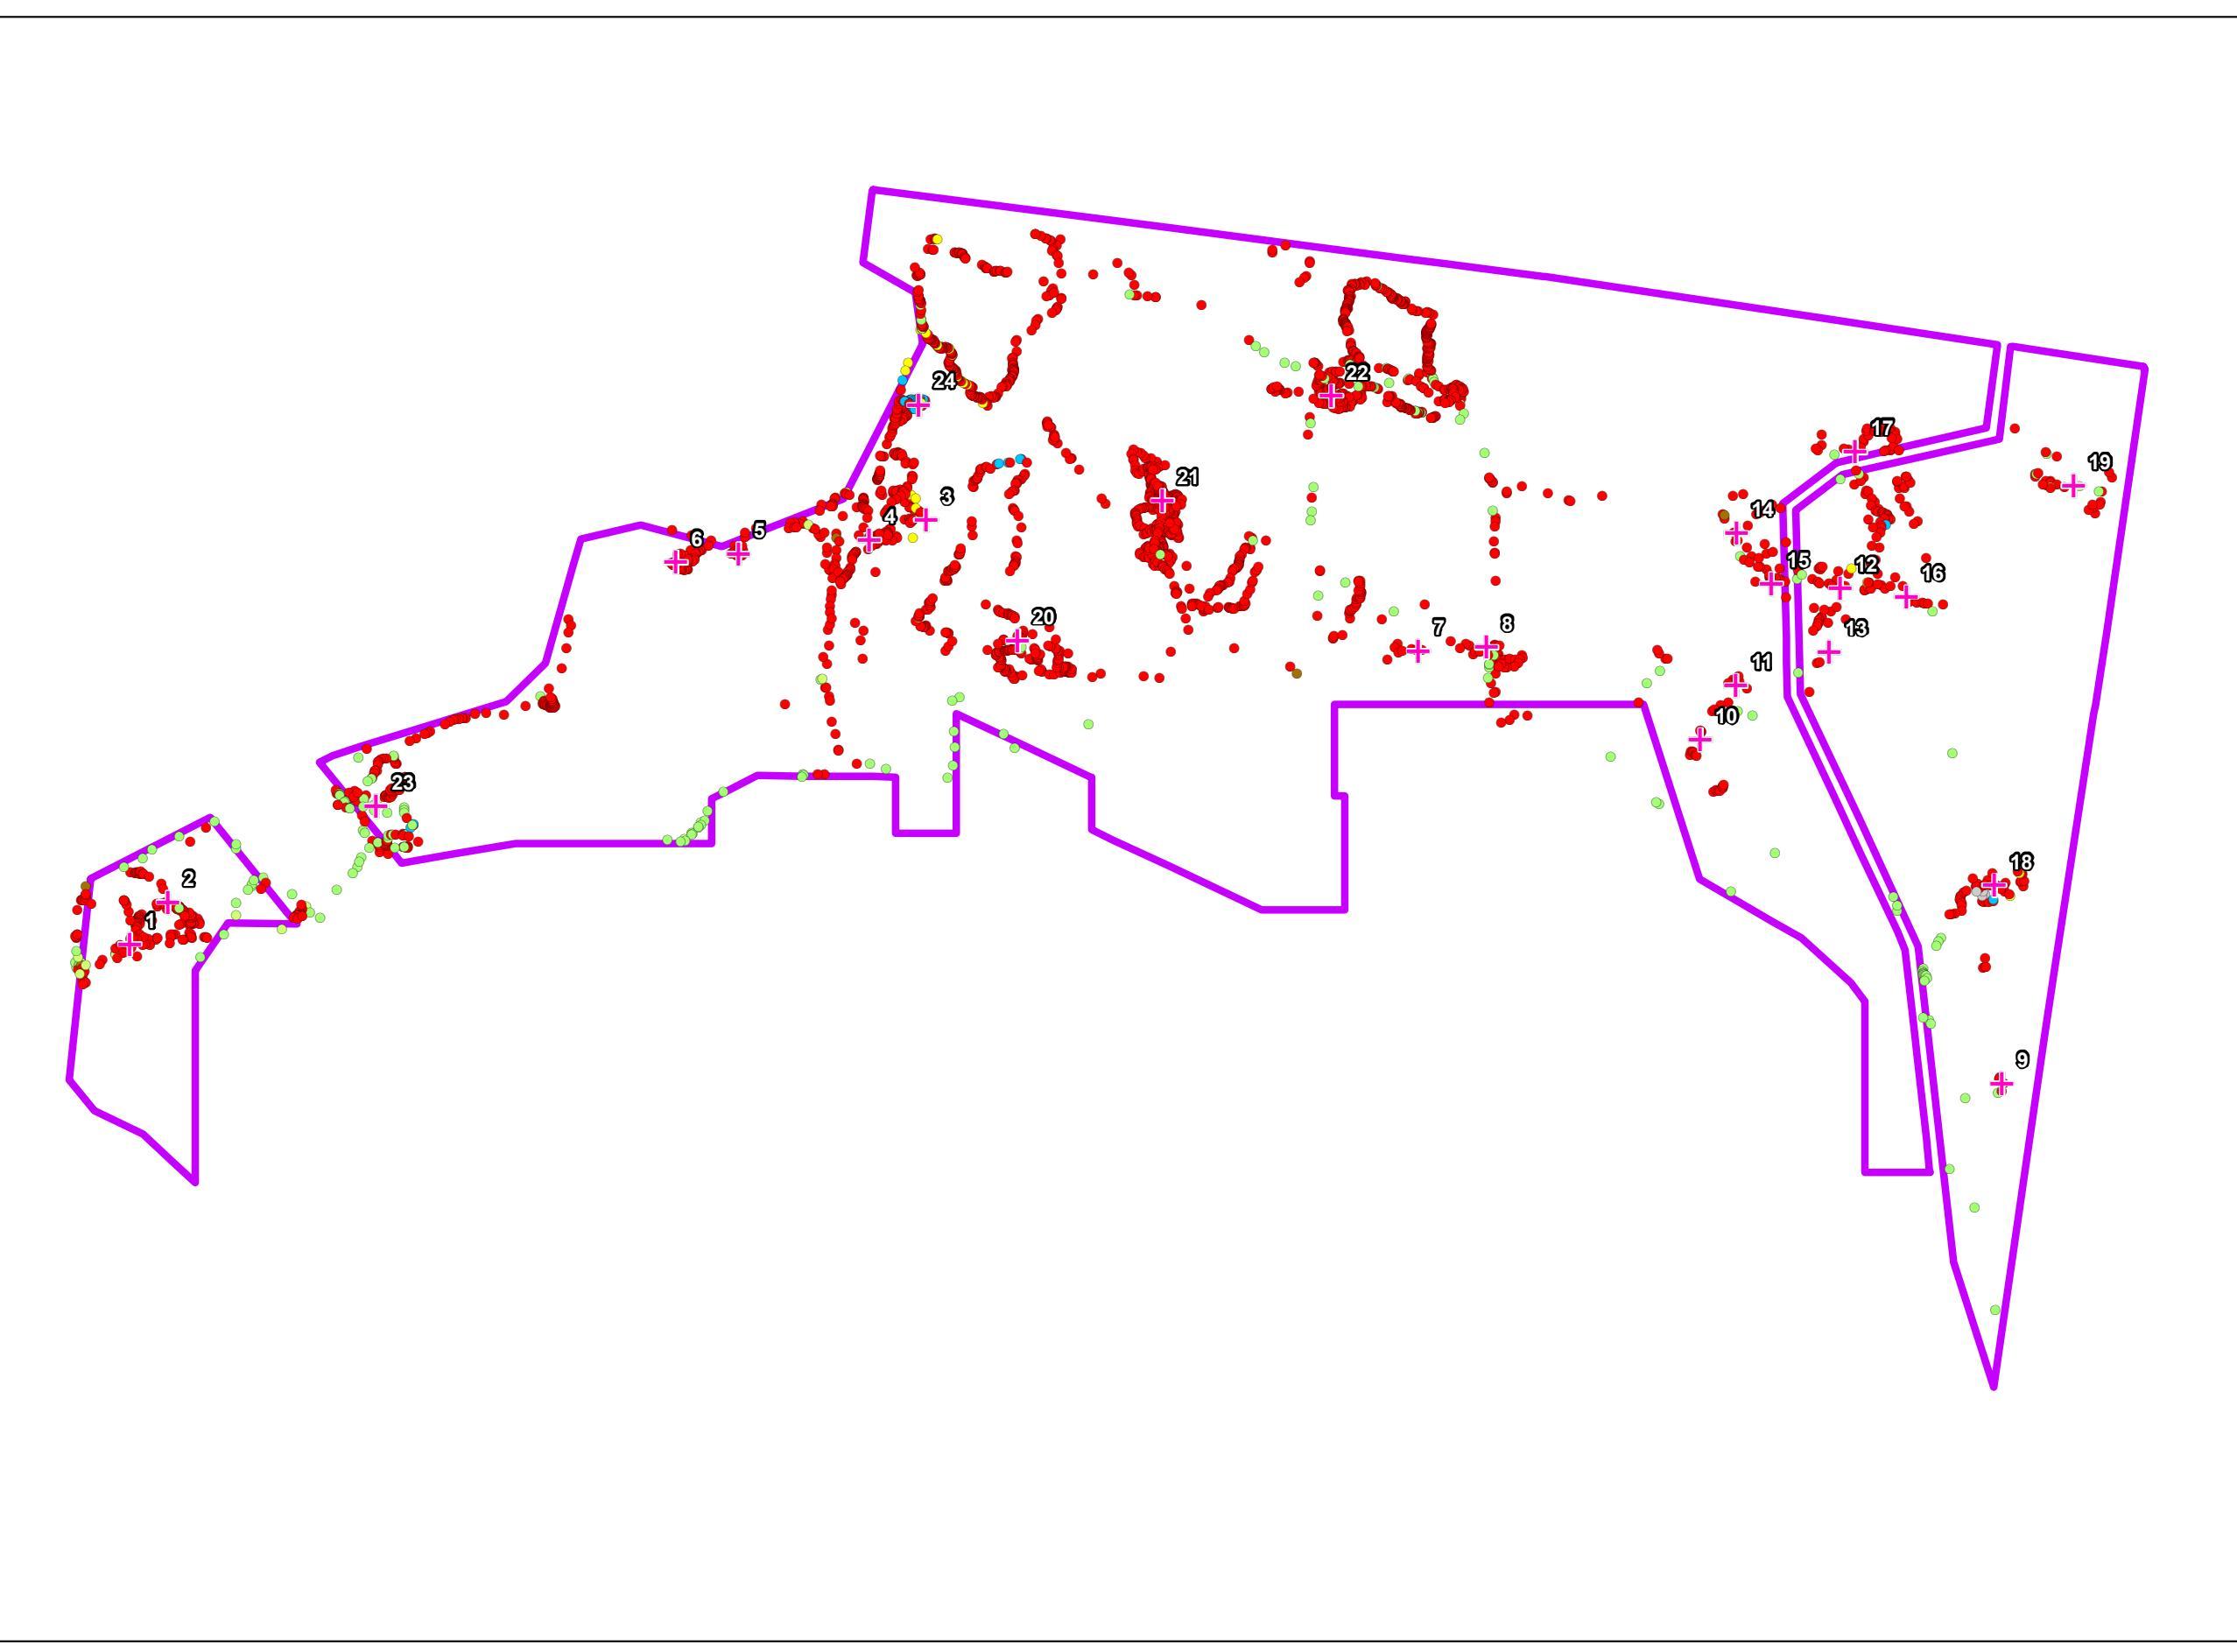
High threat weed specimen location

- Cats Claw Creeper
- Giant Rat's Tail Grass
- Groundsel
- Lantana camara
- Tecoma stans
- Opuntia

It was noted that infestation of High Threat Weed's (HTW) is unevenly distributed across the offset site. A higher concentration of Giant Rat's Tail (GRT) was occurred on Lot 157 as compared to the other land parcels within the offset. A higher proportion of Yellow Bells (*Tecoma stans*) were noted in gully areas, and Lantana (*Lantana camara*) infestations are scattered across the site, albeit occurring in higher density in gullies.

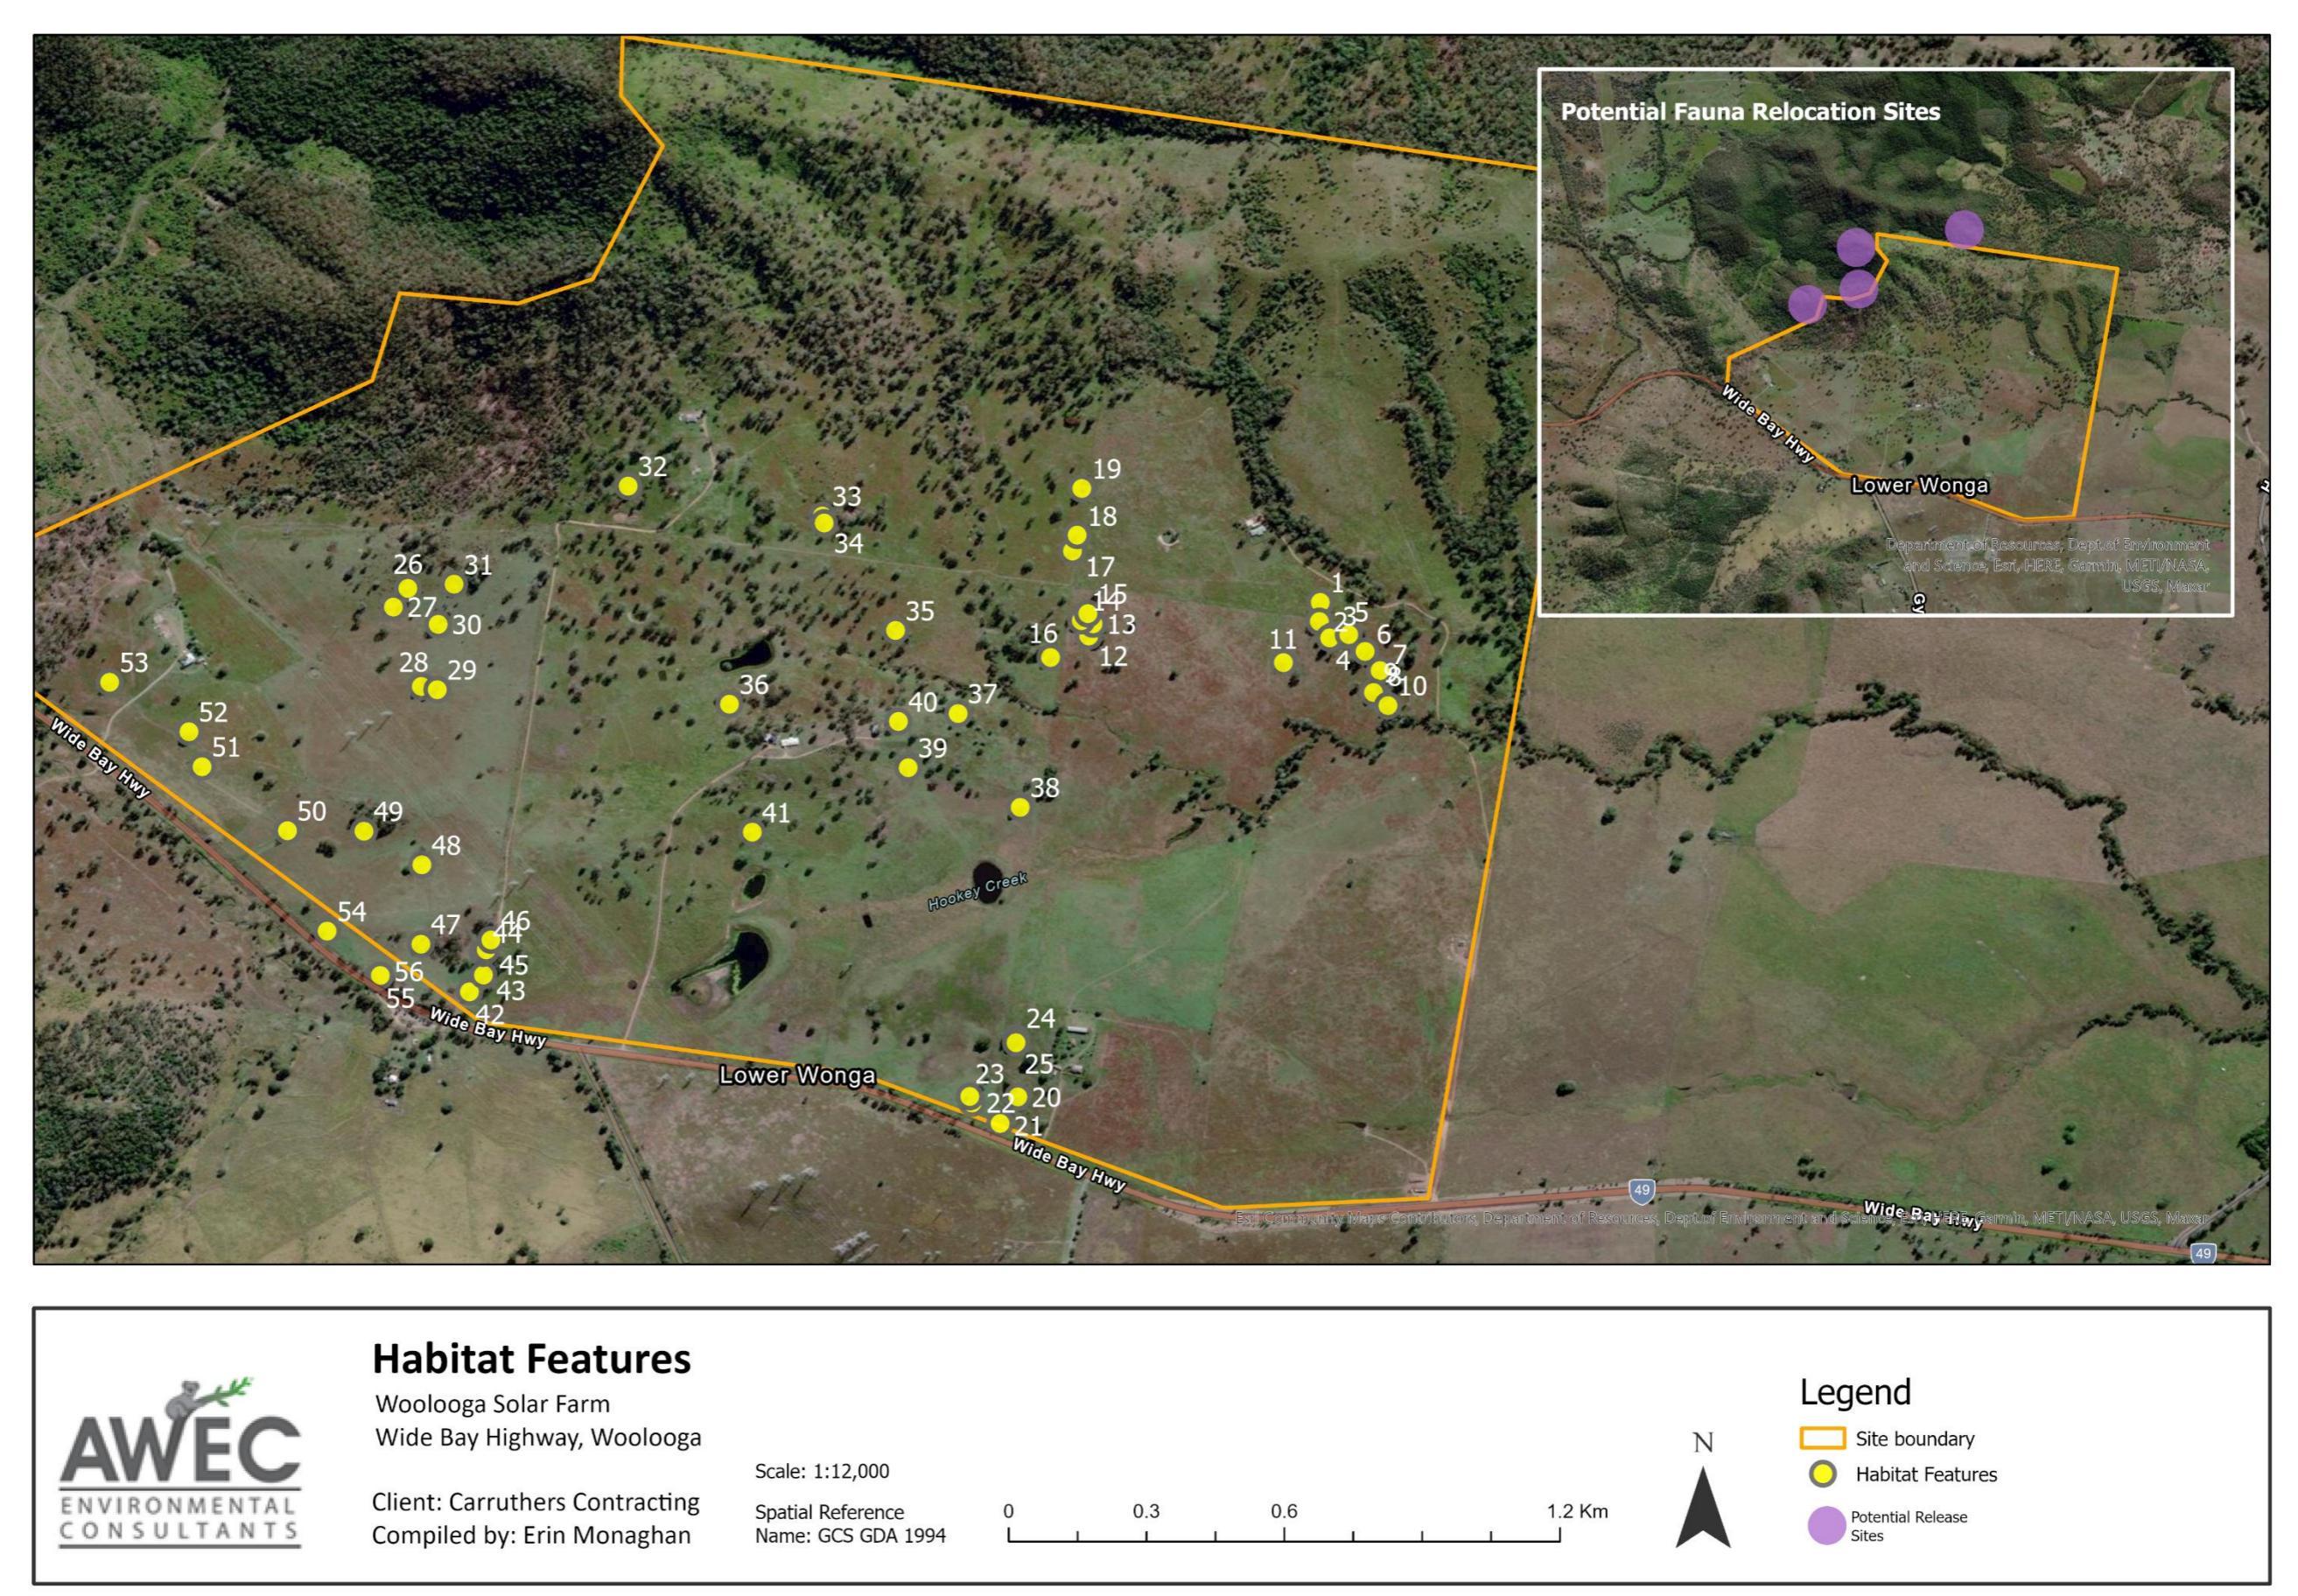
FIGURE 2- HABITAT FEATURES AND FAUNA RELOCATION

There was a total of 56 observations recorded, 40 of these were habitat features (hollows, fissured bark, woody debris, termite mounds) and 22 were fauna signs (nests, diggings and scratch marks) (**TABLE 4, FIGURE 2**). Some trees showed signs of koala scratch marks, but no individuals or scat were sighted.

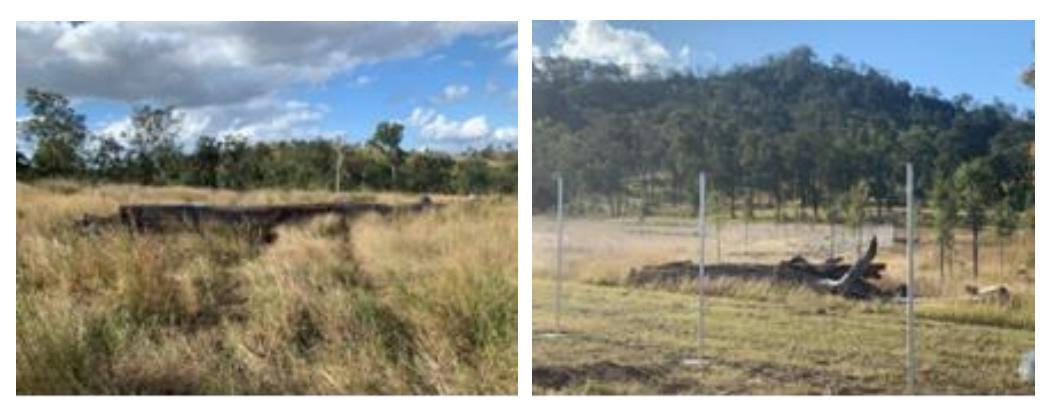
FIGURE 2 - IMAGES TAKEN ON SITE (Images of woody debris piles on site).
